**Re: Construction hazards at Eglinton Junior Public School  
ECOH Project No. 19133**

Appendix: Site Photographs

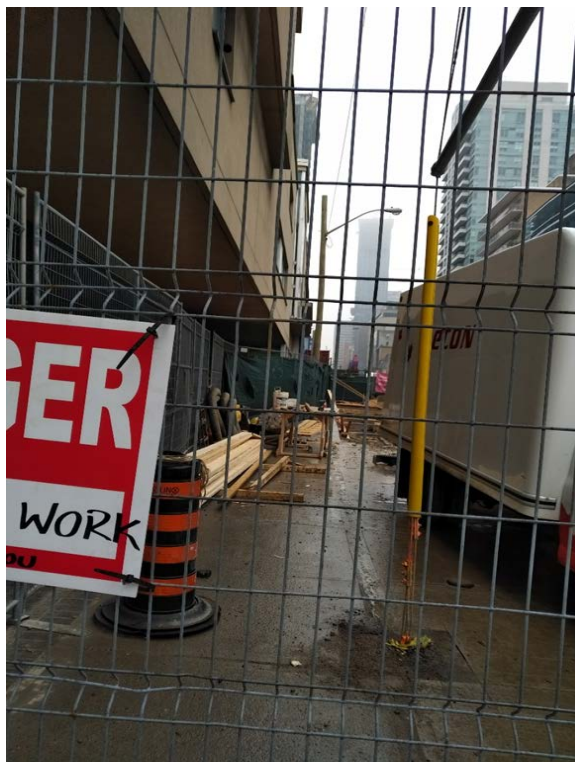
**Photo No. 1.**

1. Hoarding wall made of metal grating, covered in some areas with plastic, has been erected to enclose the construction site. (Photos 1 and 2, Appendix)
2. Site activities at the time of the visit consisted of excavating ground from the trench by means of the excavator. (Photo 3)

**Hoarding wall  
(metal grating)  
around LRT  
Construction site**

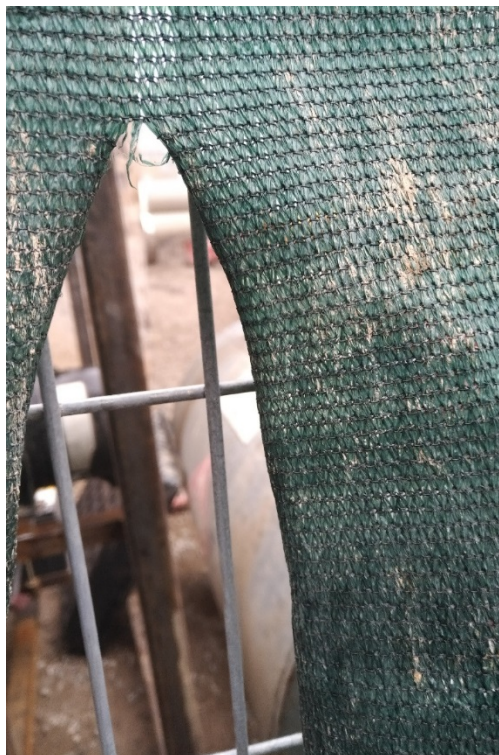
**Photo No. 2.**

**Plastic sheeting  
on metal grating  
around  
construction site**

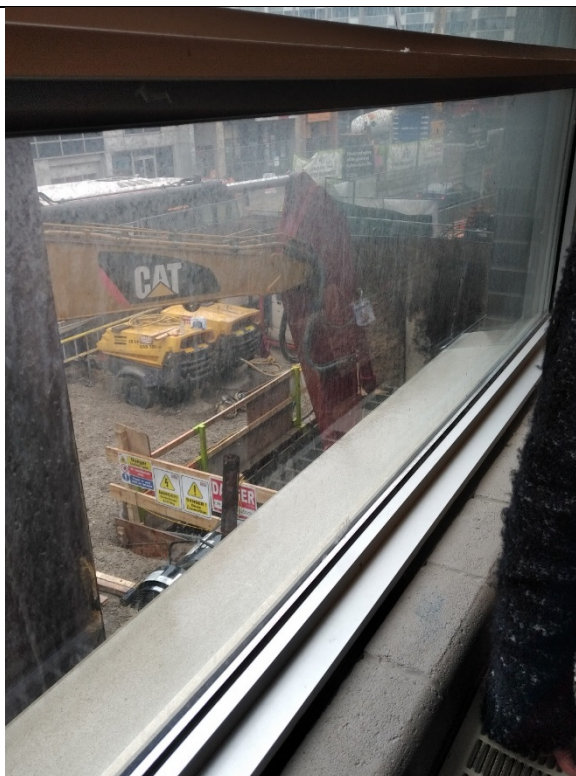
**Photo No. 3.**

5. While during the visit the excavator bucket was not observed to swing close enough to the school to present a danger, construction activities conducted close to the north side of the school pose a risk of injury or damage if equipment or materials strike the school wall or windows. Discussions should be held with the constructor about mitigating these risks, and consideration be given to installing barriers to protect the school.

**Excavator on  
construction site,  
view from third  
floor classroom  
window**

- a. Physical Barriers: TDSB should hold discussions with the City, the constructor/Metrolinks regarding feasibility of a physical barrier to prevent equipment and materials from striking and damaging the school particularly the glass windows. (A meeting between the constructor and TDSB has been arranged for Friday, April the 13th, 2018 afternoon to discuss various options to provide physical barriers)  
Note: If the constructor retains a temporary barrier such as the bin that is now outside the north-west area of the school, it should be placed so that it is not open at the top. Water presently in the bin should be drained in a safe manner.

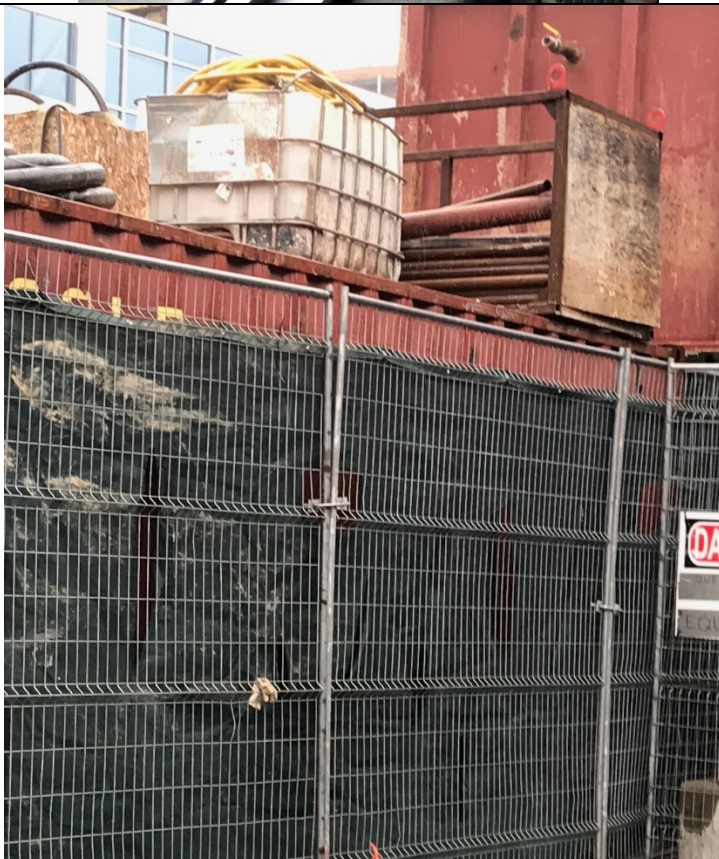
**Photo No. 4.**

3. EJPS Door #6 on the North West corner of the school exits very close to the construction site. Materials are stacked within the site against the hoarding grate. Sandbags have been placed along the bottom of the hoarding wall, presumably to make it more stable. (Photos 4,5 and 6)

1. The area outside Door #6 may pose several safety hazards if children are present near the site. As the placement of sandbags suggests that the hoarding wall may be unstable, there is a danger that it may fall over, or the materials stored against this may fall. It is therefore advisable that a barrier be erected to prevent children from being close to the hoarding in this area. The barrier could be openable by TDSB staff and contractors, as staff need access to this area to remove waste and conduct other maintenance functions.

**Grating in area near  
Door #6 showing  
material stored  
against/above  
hoarding wall**

- b. A barrier should be installed enclosing the area adjacent to the project outside EJPS Door #6, to prevent children from accessing this area. The barrier can be openable by TDSB staff when they need access.

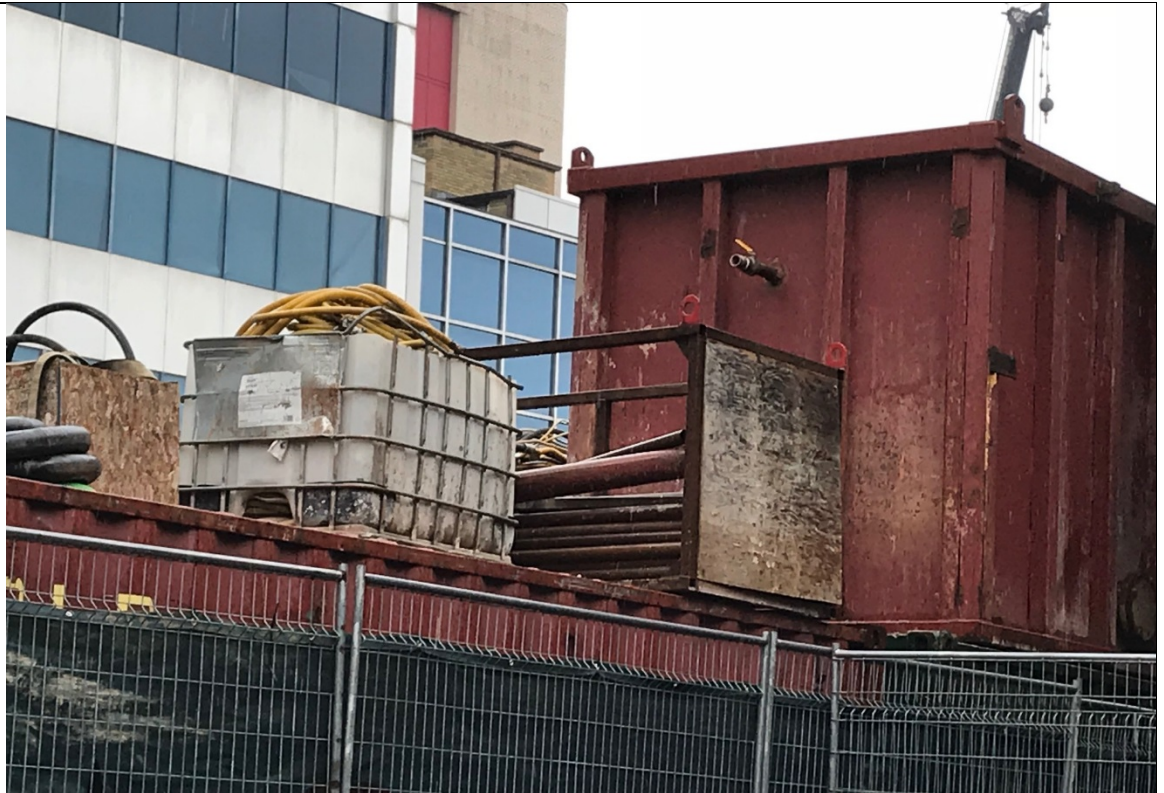
**Photo No. 5.**

**Closer view of  
material stored  
against/above  
hoarding wall near  
Door #6**

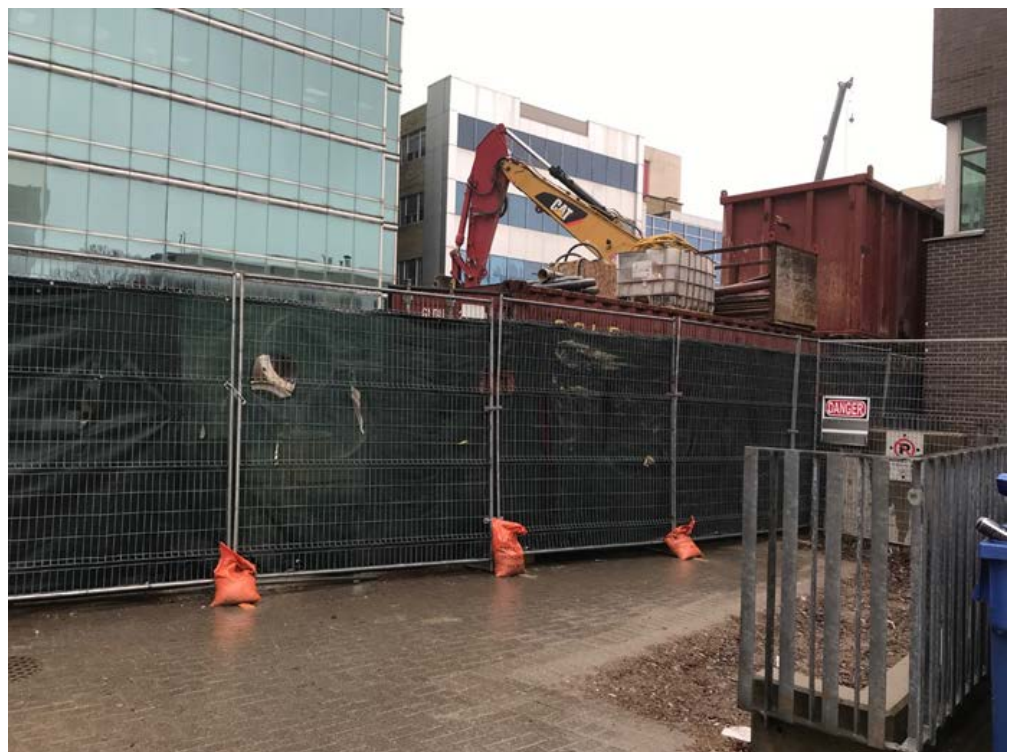
**Photo No. 6.**

5. Two bins are stacked against the hoarding wall about 1 meter from the western section of the school's north wall. The higher of these two bins (Photo 6) was reported to have been placed there after the episode of the bucket approaching the window, to form a barrier to protect the school. This bin is open at the top. As it was raining at the time of the visit, the bin was collecting rain water. It was not observed to contain any other materials (Photo 8).

**View of area outside  
Door #6 showing  
sandbags  
supporting hoarding  
wall and bin near  
school wall.**

1. The West Entrance:
  - a. The hoarding wall should be more rigidly secured such that it wouldn't be necessary to use sand bags to stabilize the hoarding wall.

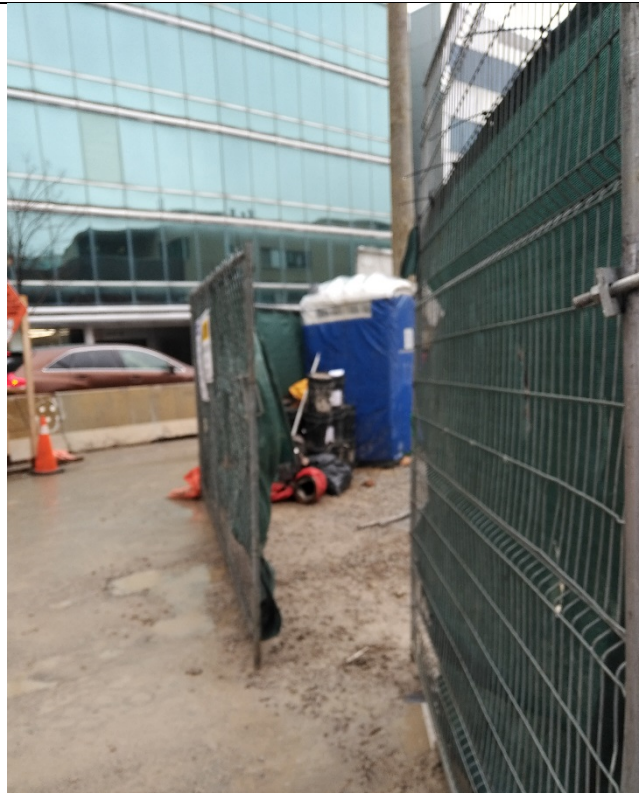
**Photo No. 7.**

4. There is an opening in the hoarding wall for entry and exit to the site on the west side of the project (Photo 7). This appears to be left open on a permanent basis and is not guarded.

2. There is a risk that children may enter the site itself through the unguarded opening on the west side of the project. Steps should be taken to prevent this possibility, either through guarding the entry or keeping it closed to prevent unauthorized access. A less desirable option is to relocate the entry so that it is less accessible from the school.

**Opening in  
hoarding wall for  
entry/exit to site**

- c. The constructor should be asked to take steps to prevent access by unauthorized persons through the entry point on the west side of the project.

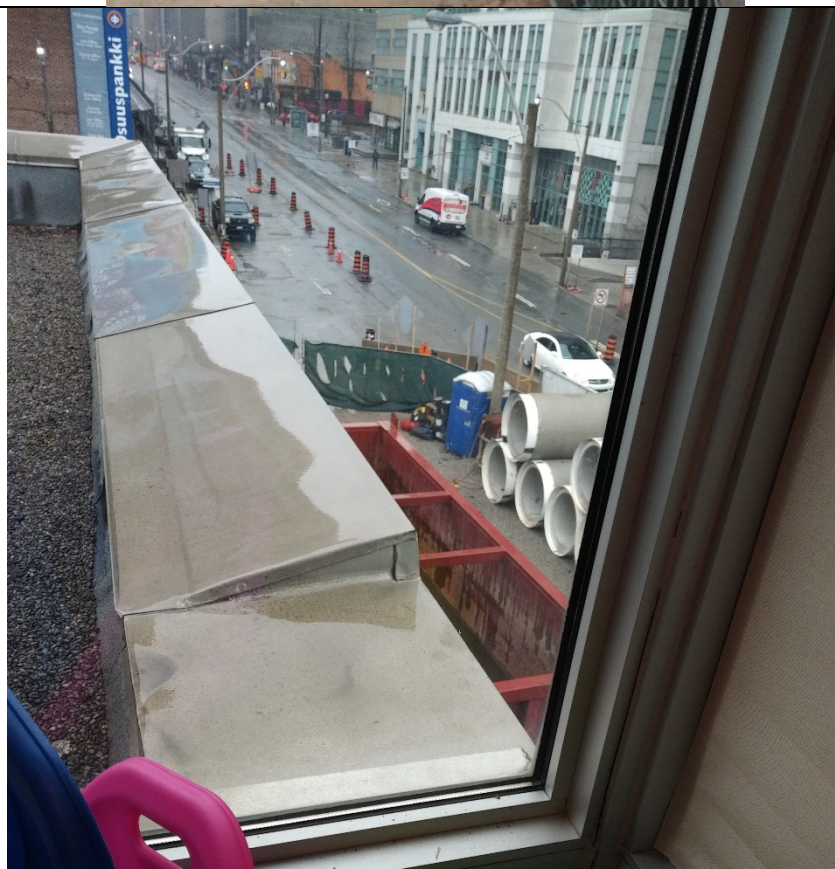
**Photo No. 8.**

6. Although materials are not being stored or placed in the bin that has been placed opposite the western area of the north school wall, concerns may arise that materials are being dumped into this bin. Furthermore, the bin was observed to be collecting rainwater. Accumulation of stagnant water or contamination of this water can be a hazard due to infestation by insects or other biological agents, especially as weather gets warmer.

**Top of bin seen  
from third floor  
classroom, showing  
water collecting  
inside**

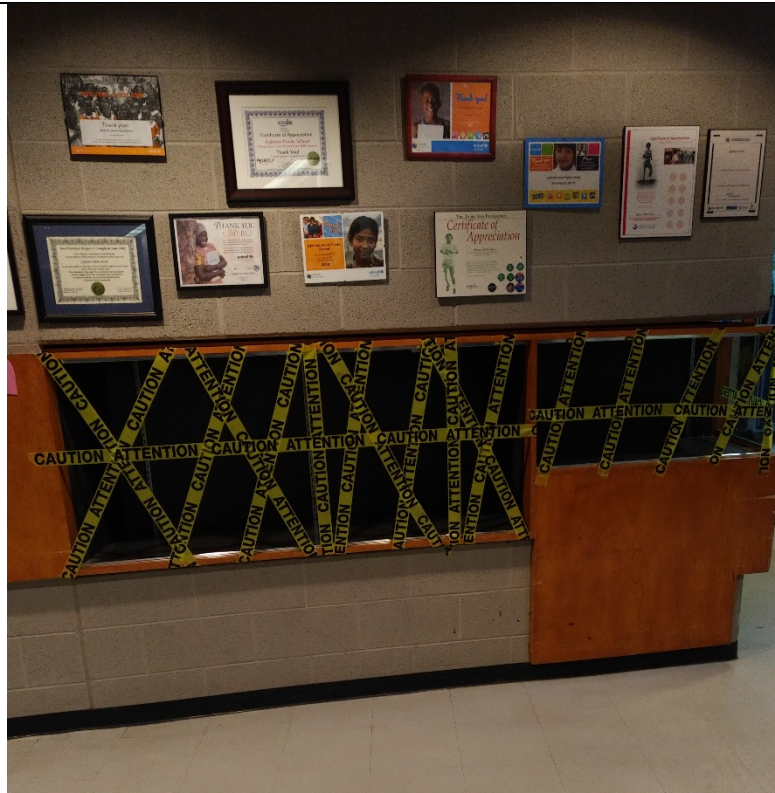
**Photo No. 9.**

10. Staff reported effects on the school attributed to vibration from the project. These included minor wall cracks and separation of panels from the frames of glass-enclosed cabinets on the ground floor, prompting removal of some of the glass panels (Photo 9)

7. There is a possibility that vibration levels are high enough to affect school structure.

Cabinet on floor one  
of school, glass  
removed due to  
settling attributed to  
vibration. Gap  
between frame and  
wall can be seen.

While major effects are not expected, vibration should be assessed or information obtained from the constructor about measured vibration levels.
