PRE-RENOVATION DESIGNATED SUBSTANCE SURVEY

**TDSB Solar Roofing Project
Givins/Shaw Junior Public School
SAP# 3772
49 Givins Street, Toronto, Ontario**

**ECO Project No.: 17108
May 30, 2018**

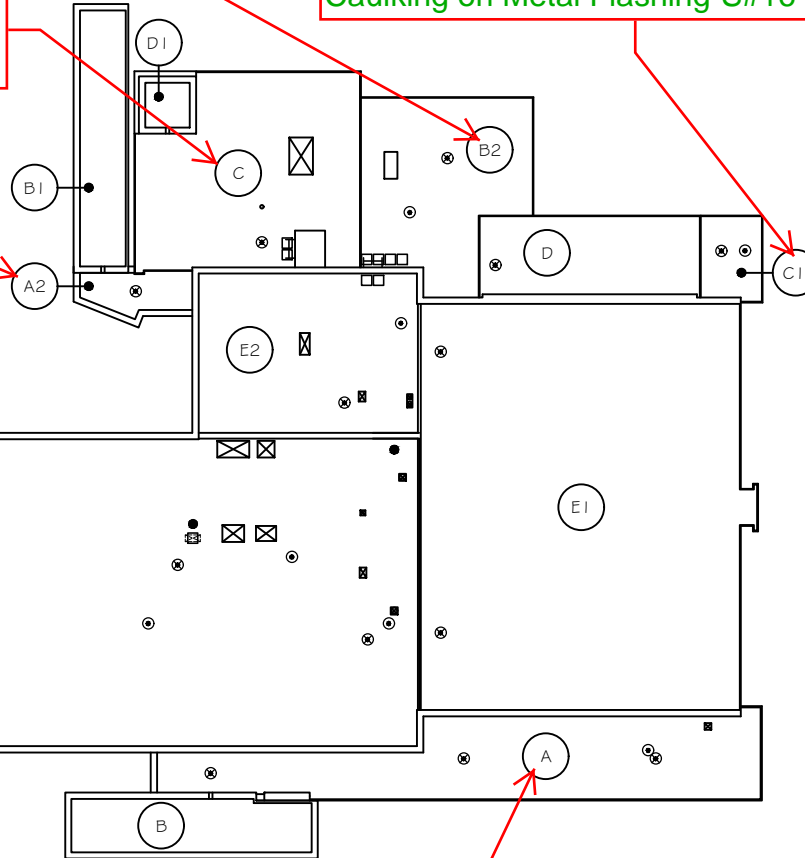
Sheet Title
Roof Plan

Roofing Materials - S#7 - ND
Caulking on Metal Flashing-S#8-Black-ND
Caulking on Metal Flashing (1LF)-S#9-Grey-3%
Caulking on Metal Flashing-S#10-White-ND

Roofing Materials - S#11 - ND
Caulking on Metal Flashing-S#12-Black-ND
Caulking on Metal Flashing (35LF)-S#13-Grey-5%
Caulking on Skylight-S#14-Clear-ND

Roofing Materials - S#5 - ND
Caulking on Metal Flashing-S#6-Grey-ND

Roofing Materials - S#15 - ND
Caulking on Metal Flashing-S#16-Black-ND

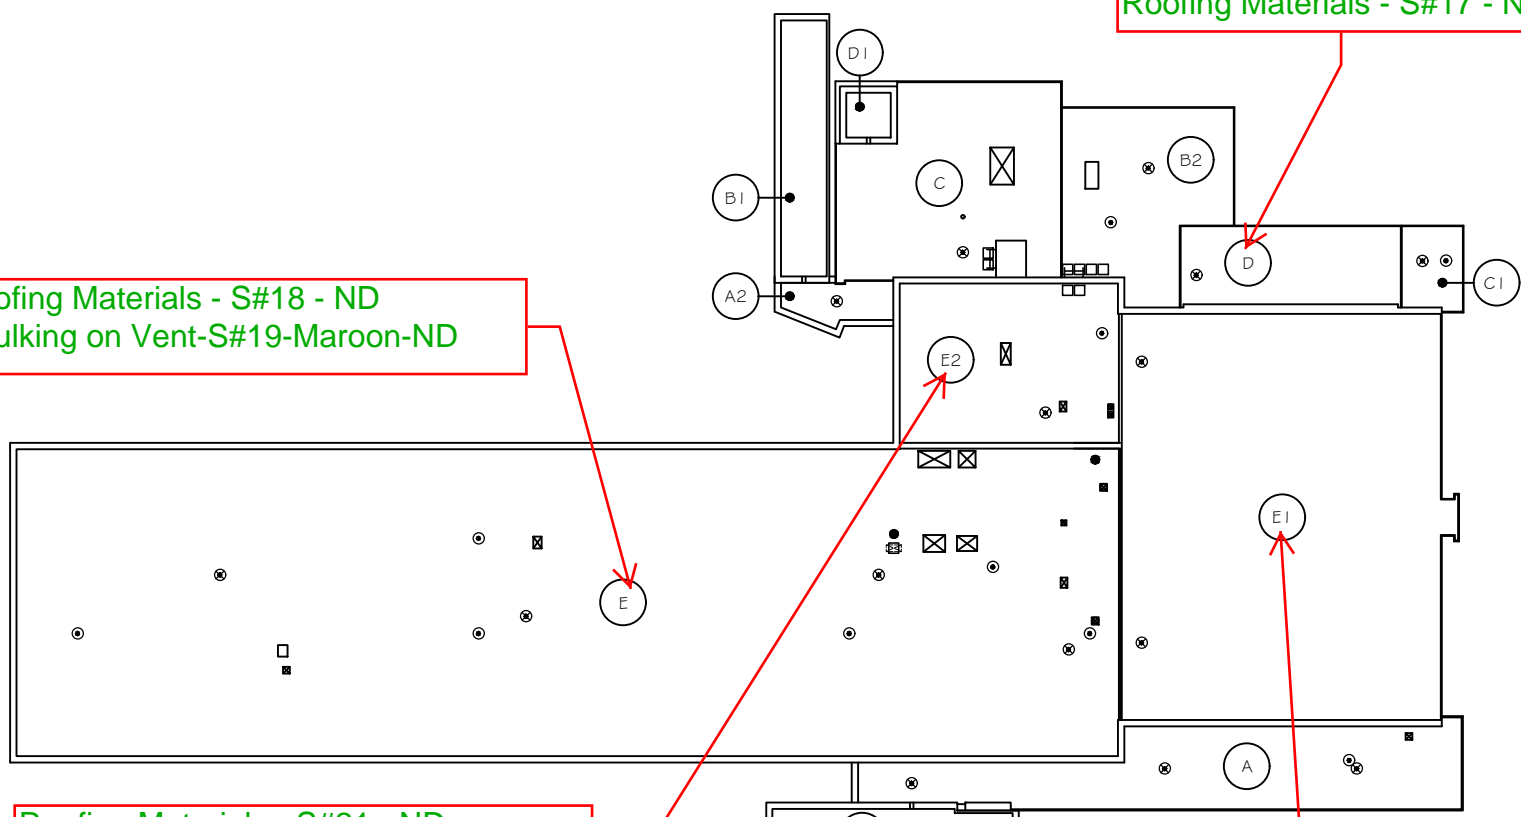
Sheet Title
 Roof Plan

Roofing Materials - S#17 - ND

Roofing Materials - S#18 - ND
 Caulking on Vent-S#19-Maroon-ND

Roofing Materials - S#21 - ND
 Caulking on Vent-S#22-Purple-ND
 Caulking on Vent-S#23-White-ND

Roofing Materials - S#20 - ND
