## **INDOOR AIR QUALITY ASSESSMENT**

### **Runnymede Junior and Senior Public School 357 Runnymede Road, Toronto, Ontario**

**Presented to:**  
**Toronto District School Board**  
5050 Yonge Street  
North York, Ontario  
M2N 5N8

**Maple Project No. 20748-8**

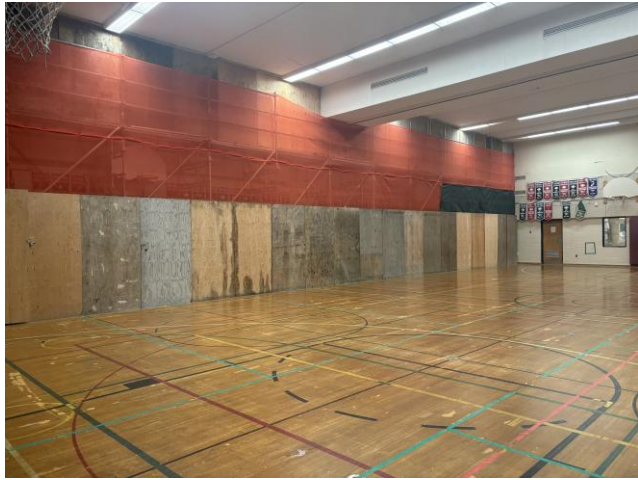
- Scaffolding was observed to be present on the east side within the Gym. Plywood hoarding was observed to be present around the scaffolding. A debris netting was observed to be present around the scaffolding for dust/debris control.

**Figure 1:** View within the Gym with plywood hoarding and debris netting on east side.

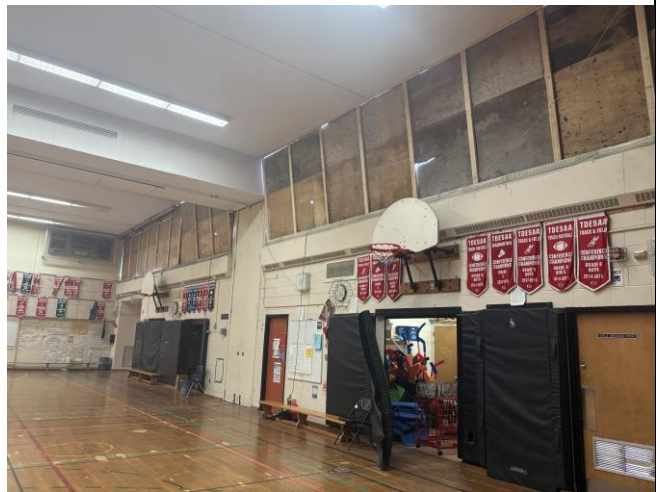
**Figure 2:** View of plywood hoarding on west windows where previously removed.

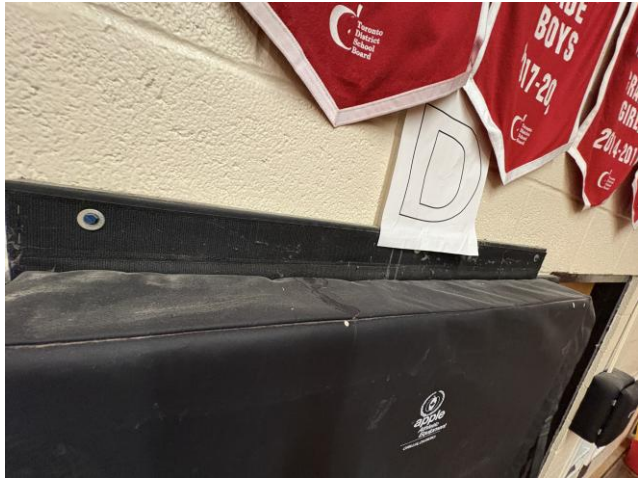
- Plywood hoarding was observed to be present around openings on the west windows where windows were previously removed.
- Evidence of accumulated dust/debris was observed to be present on horizontal surfaces within the accessed areas.

**Figure 3:** General view of horizontal surfaces with settled dust/debris in the Gym (typical).

- Remove and replace all HVAC air filters.
- Surface clean all horizontal surfaces within the Gym and the adjacent areas with visible evidence of accumulated settled dust/debris where present.
- Consider installing HEPA filtered air scrubbers within the Gym during the construction work hours to clean air in an attempt to reduce dust/debris generated from the ongoing construction.
- Consideration should be given to have the ductwork serving the Gym be cleaned by a qualified contractor.
- Consider installing a debris netting on the west windows around the plywood hoarding to control dust/debris generated from the construction.
- The plywood hoarding and debris netting appears to not capture the fine particulates within the construction work area, the general contractor may consider using a different methodology to control fine particulates generated from the Work Area.

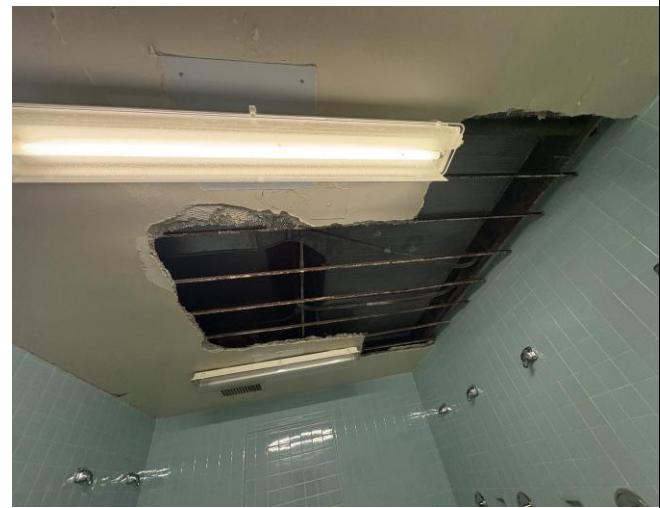
**Figure 4:** General view opening present on plaster ceiling within Girl's Changeroom.

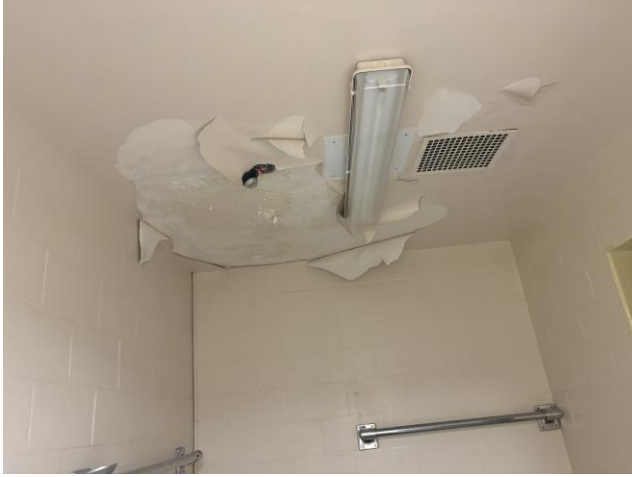
**Figure 5:** General view plaster ceiling within Boy's Changeroom.

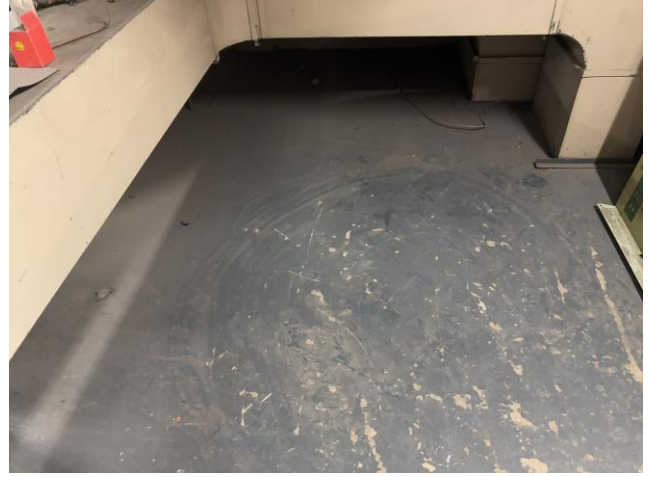
**Figure 6:** General view of horizontal surfaces with accumulated dust/debris present within Fan Room around ductwork (typical).

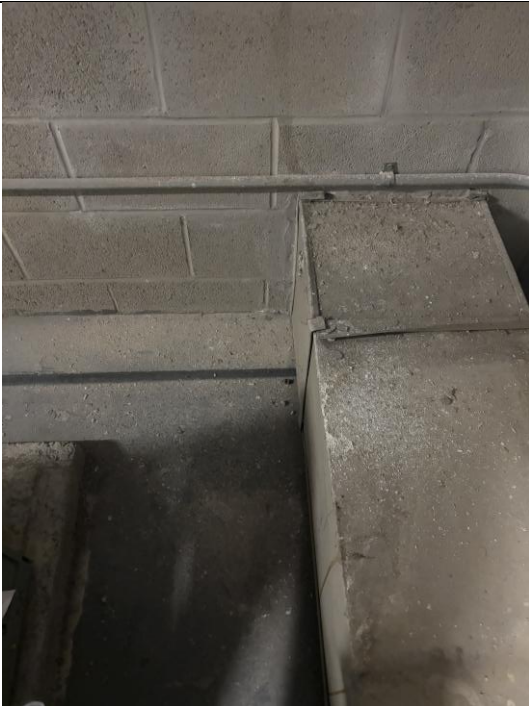
**Figure 7:** General view of horizontal surfaces with accumulated dust/debris present within Fan Room around ductwork (typical).

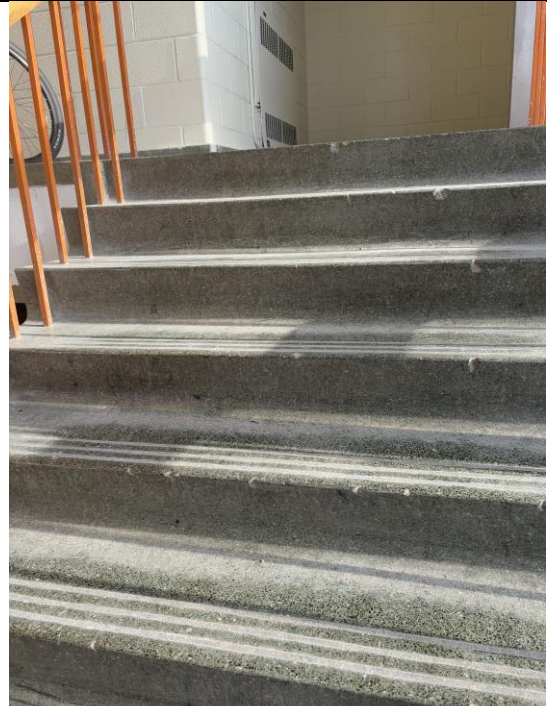
**Figure 8:** General view of horizontal surfaces with accumulated dust/debris present within Staircase 6 (typical).

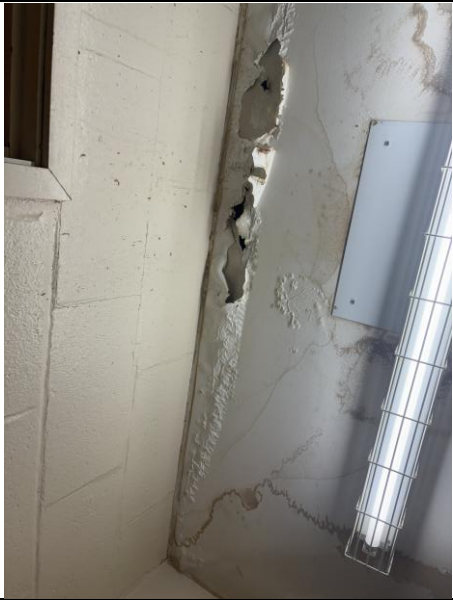
**Figure 9:** General view of peeling paint and efflorescence on plaster ceiling within assessed areas.

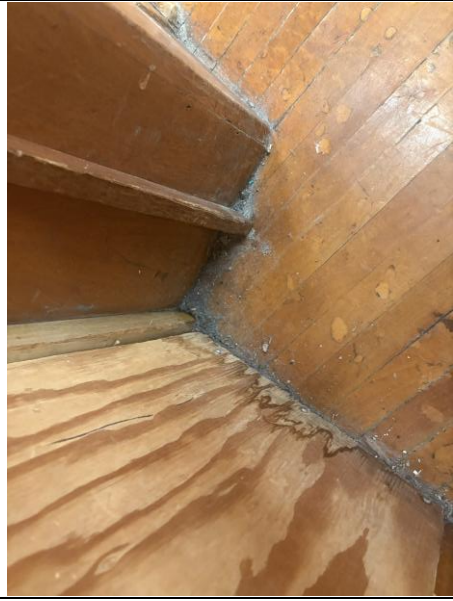
**Figure 10:** General view of horizontal surfaces with accumulated dust/debris present within Gym (typical).

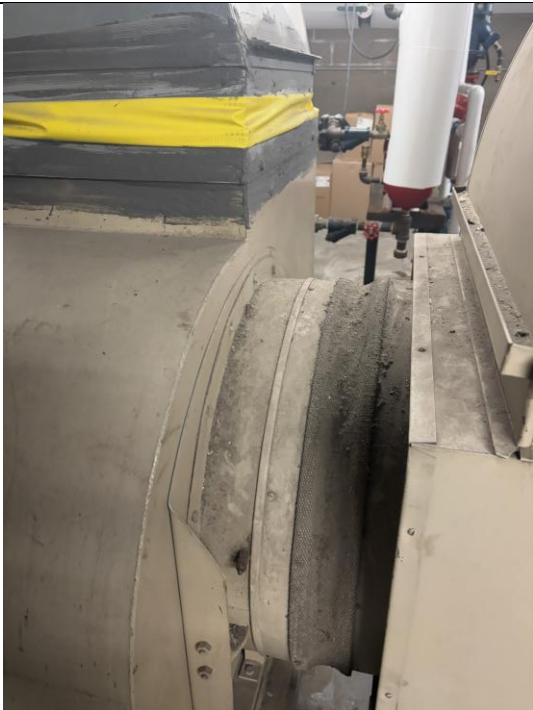
**Figure 11:** General view of horizontal surfaces with accumulated dust/debris present within Fan Room around ductwork (typical).

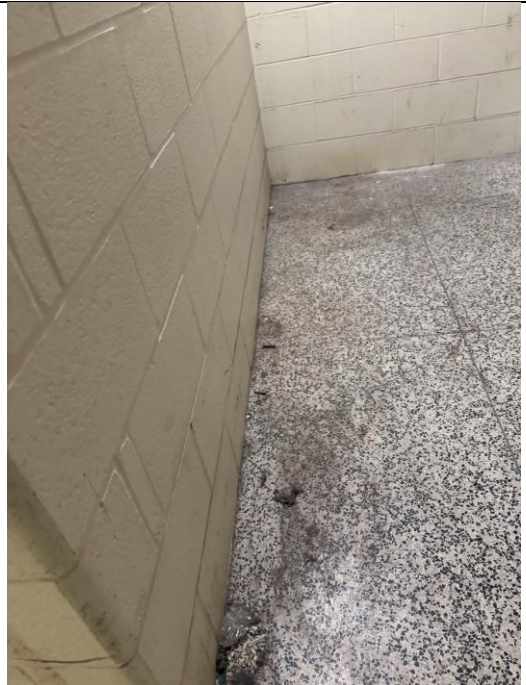
**Figure 12:** General view of horizontal surfaces with accumulated dust/debris present within Fan Room.
