Site Safety Inspection Report

Company Toronto District School Board	Location/Address 357 Runnymede Road, High Park North, Old Toronto, Ontario, M6P 3C5, Canada		
Date June 23, 2025	Time In: 8:00 AM	Time Out: 10:00 AM	Weather Scattered Clouds, 25°C, 4 km/h Winds
Project	Supervisor TCM - Cillian	Safety Inspector Nicole Stephens	Title TDSB Site Inspection Report for Runnymede JSPS at 357 Runnymede Rd Project Jun 23, 2025

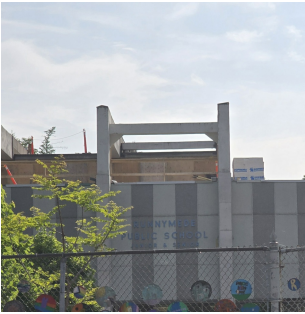
Item Site Information INFO Regulation Site Information INFO Action N/A	SDS arrived on site at 8:00 am to observe the construction work being performed at Runnymede JSPS and how the work is effecting the school and its occupants. Discussed site conditions with Paul. Observed ten workers on site and work consists of concrete repairs and roofing.
2.

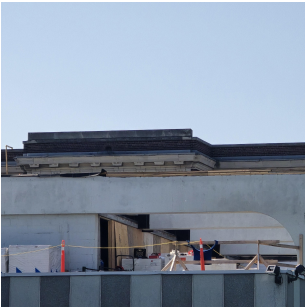
Item Bump Lines Regulation #207 (1) (213/91) Action N/A	Observed that adequate barriers are erected in the work area at least 2 meters from the perimeter of the roof, which meets compliance.
3.

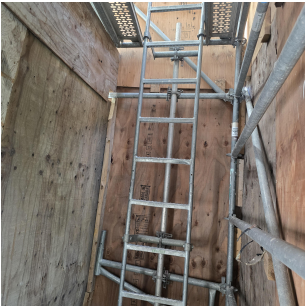
Item Scaffolding - Access Means Regulation #135 (1)(d) (213/91) Action N/A	Observed an adequate means of access/egress to the scaffolding is available, which meets compliance.

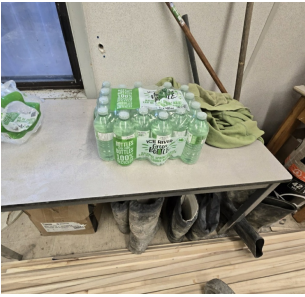
Item Drinking Water Regulation #28 (1) (213/91) Action N/A	Observed that drinking water is readily available to the workers at the project, which meets compliance.

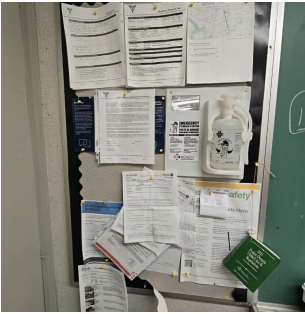
Item Safety Board Regulation #25 (i) OHSA Action N/A	Observed that the project safety board was on site and had the required documentation and postings, which meets the requirements of OHSA.

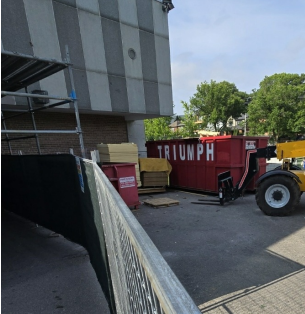
Item Housekeeping Regulation #35 (1) (213/91) Action On-Going	Observed waste materials and debris being removed to waste disposal containment areas/bins at least daily, which meets compliance.

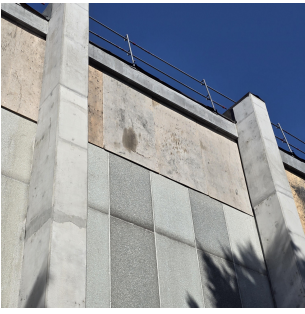
Item Guardrail System - Required Regulation #26.3 (1) (213/91) Action N/A	Observed a work area that had an open side that exposed the workers to a fall of greater than 2.4 meters with an adequate guardrail in place, which meets compliance.
