Site Safety Inspection Report

Company Toronto District School Board	Location/Address 357 Runnymede Road, High Park North, Old Toronto, Toronto, Ontario, M6P 3C5, Canada		
Date June 9, 2025	Time In: 7:30 AM	Time Out: 9:30 AM	Weather Overcast Clouds, 16°C, 8 km/h Winds
Project	Supervisor TCM - Cillian	Safety Inspector Mike Harrison	Title TDSB Site Inspection Report for Runnymede JSPS at 357 Runnymede Rd Project Jun 9, 2025

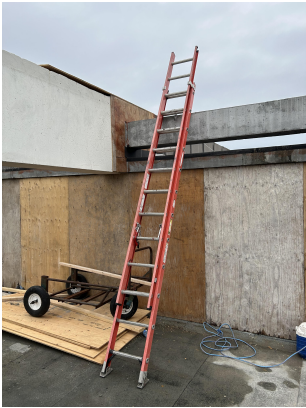
2.

Item Ladders for Access / Egress - Securement Regulation #82 (2)(d) (213/91) Action Supervisor	Per previous report, observed a ladder being used as access/egress that is not secure. Discussed the issue with the supervisor and he shall ensure the securement of ladders at the top and bottom to prevent ladder movement to meet compliance.

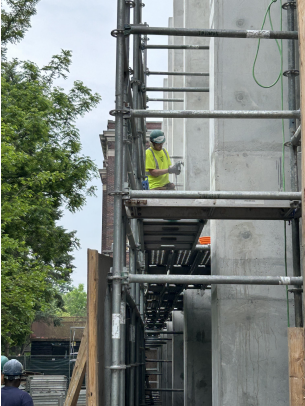
6.

<p>Item PPE</p> <p>Regulation #21 (213/91)</p> <p>Action N/A</p>	Observed workers on site are wearing the required PPE for the safe performance of their tasks, which meets compliance.

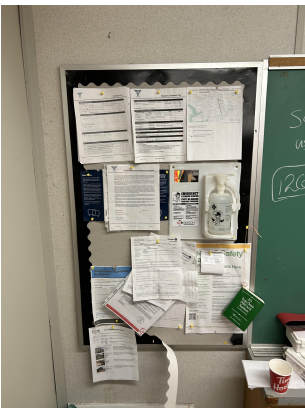
10.

<p>Item Safety Board</p> <p>Regulation #25 (i) OHSA</p> <p>Action N/A</p>	Observed that the project safety board was on site and had the required documentation and postings, which meets the requirements of OHSA.
