# Site Safety Inspection Report

Company Toronto District School Board	Location/Address 357 Runnymede Road, High Park North, Old Toronto, Toronto, Ontario, M6P 3C5, Canada		
Date June 16, 2025	Time In: 8:00 AM	Time Out: 10:00 AM	Weather Clear Sky, 19°C, 9 km/h Winds
Project	Supervisor TCM - Cillian	Safety Inspector Nicole Stephens	Title TDSB Site Inspection Report for Runnymede JSPS at 357 Runnymede Rd Project Jun 16, 2025

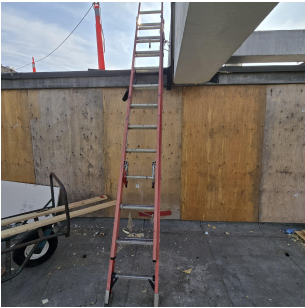
<b>Item</b> Ladders for Access / Egress - Securement <b>Regulation</b> #82 (2)(d) (213/91) <b>Action</b> Issue Corrected	Per previous report, observed that a ladder being used as access/egress is now secure at the top and bottom to prevent ladder movement, which meets compliance.
3.

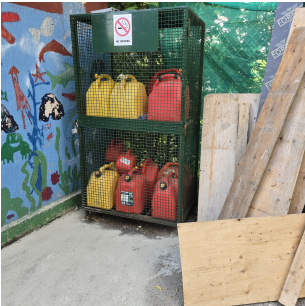
<b>Item</b> Flammable Liquid Storage <b>Regulation</b> #43 (2) (213/91) <b>Action</b> N/A	Observed that flammable liquids are being stored in well ventilated areas, which meets compliance.

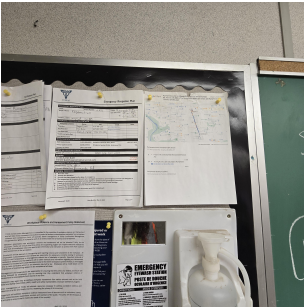
<b>Item</b> Constructor - ERP Posting <b>Regulation</b> #17 (3) (213/91) <b>Action</b> N/A	Observed that an emergency response plan was posted on the site and is readily available to the workers, which meets compliance.

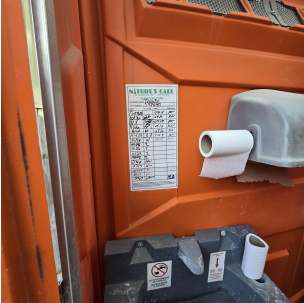
<b>Item</b> Facilities - Location / Service <b>Regulation</b> #29 (7) (9) (11) (213/91) <b>Action</b> N/A	Observed facilities supplied at the project which meets the table in section 29.1 of the regulation. Also observed service records for facilities and location of facilities, which meets compliance.

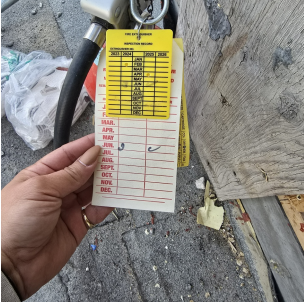
<b>Item</b> Fire Extinguisher - Inspection <b>Regulation</b> #55 (213/91) <b>Action</b> N/A	Observed fire extinguisher with inspection tags in place and inspections dated and signed off monthly, which meets compliance.

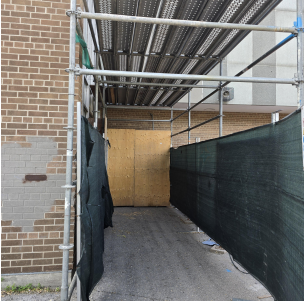
<b>Item</b> Overhead Protection - Public Way <b>Regulation</b> #64 (1) (213/91) <b>Action</b> N/A	Observed overhead protection installed for public way protection for a project located 4.5 meters or less from the public way, which meets compliance.

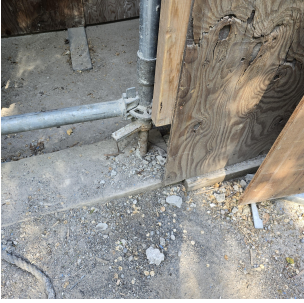
<b>Item</b> Scaffolding - Footings, Sills, Supports <b>Regulation</b> #128 (1)(c) (213/91) <b>Action</b> N/A	Observed that the footings, sills and supports of the scaffolding are level and secure, which meets compliance.

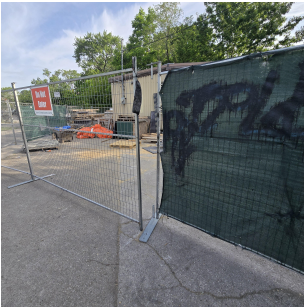
<b>Item</b> Fencing - Public Way Protection <b>Regulation</b> #65 (213/91) <b>Action</b> Issue Corrected	Observed fencing installed at least 1.8 meters in height between the project location and the public way, however openings were observed; which endangers the public. Discussed the issue with the supervisor and the openings were then closed and secure for the protection of public traffic, which meets compliance.
10.

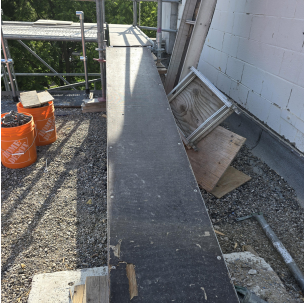
<b>Item</b> Access / Egress - Work Areas <b>Regulation</b> #70 (1) (213/91) <b>Action</b> N/A	Observed access/egress to and from work areas to be by means of ramp or ladder, which meets compliance.
