Site Safety Inspection Report

Company Toronto District School Board	Location/Address 357 Runnymede Road, High Park North, Old Toronto, Ontario, M6P 3C5, Canada		
Date June 30, 2025	Time In: 8:30 AM	Time Out: 10:30 AM	Weather Few Clouds, 23°C, 5 km/h Winds
Project	Supervisor TCM - Craig	Safety Inspector Mike Harrison	Title TDSB Site Inspection Report for Runnymede JSPS at 357 Runnymede Rd Project Jun 30, 2025

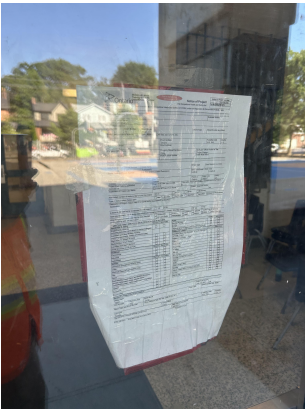
3.

Item Notice of Project - Ont. Reg. 213/91 Construction Projects - Section 13 Regulation Notice of Project - Ont. Reg. 213/91 Construction Projects - Section 13 Action N/A	Observed that a Notice of Project is posted in a conspicuous place on the site, which meets compliance.
