Site Safety Inspection Report

Company Toronto District School Board	Location/Address 357 Runnymede Road, High Park North, Old Toronto, Toronto, Ontario, M6P 3C5, Canada		
Date May 1, 2025	Time In: 8:30 AM	Time Out: 10:30 AM	Weather Broken Clouds, 8°C, 8 km/h Winds
Project	Supervisor TCM - Cillian	Safety Inspector Mike Harrison	Title TDSB Site Inspection Report for Runnymede JSPS at 357 Runnymede Rd Project May 1, 2025

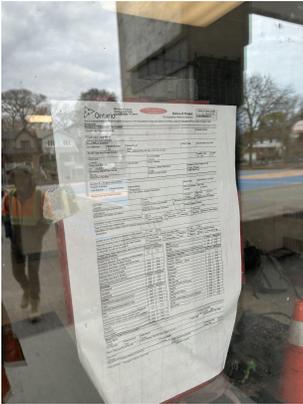
2.

Item Notice of Project - Ont. Reg. 213/91 Construction Projects - Section 13 Regulation Notice of Project - Ont. Reg. 213/91 Construction Projects - Section 13 Action N/A	Observed that a Notice of Project is posted in a conspicuous place on the site, which meets compliance.

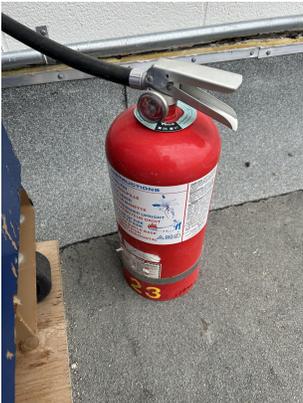
3.

Item Fire Extinguisher - Refill/Replacement Regulation # 54 (2) (213/91) Action Supervisor	Observed fire extinguisher on site that is not fully charged. Discussed the issue with the supervisor and he shall ensure all fire extinguishers on site are fully charged and that fire extinguishers that are used are refilled or replaced immediately to meet compliance.

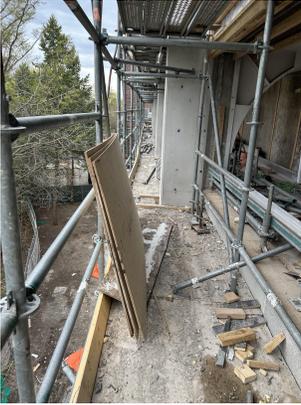
5.

Item Access / Egress - Emergencies Regulation #71 (213/91) Action Supervisor	Per previous report, observed access/egress travel routes are obstructed with wood materials and debris. Discussed the issue with the supervisor and he shall ensure access/egress travel routes are clear of obstructions for workers to exit in the event of an emergency to meet compliance.

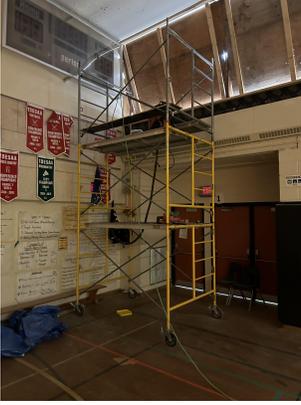
6.

Item Scaffolding on Castors/Wheels - Outriggers Regulation #129 (2) (213/91) Action Supervisor	Observed scaffolding mounted on castors/wheels at a height exceeding three times the least lateral dimension of the scaffolding. Discussed the issue with the supervisor and he shall ensure outriggers are installed so that the height of the scaffolding does not exceed three times the least lateral dimension of the scaffold system to meet compliance.

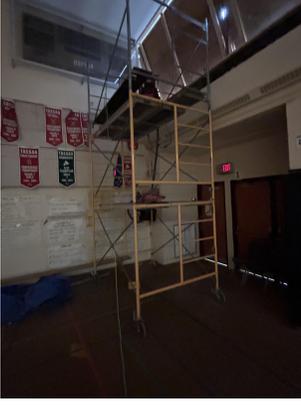
7.

Item Scaffolding - Access Means Regulation #135 (1)(d) (213/91) Action Supervisor	Observed scaffolding being used on site that does not have an adequate means of access/egress. Discussed the issue with the supervisor and he shall ensure that an adequate means of access/egress is available (stairs, ramp, runway, ladder) for the workers to access/egress the scaffolding to meet compliance.

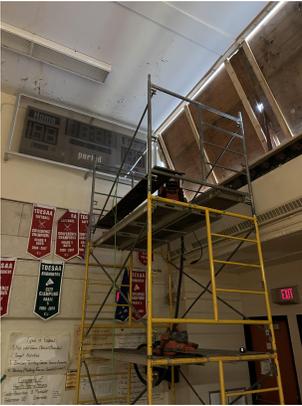
Item #	Act / Reg / Follow-Up	Observations
8.

Item Scaffolding - Guardrails Regulation #135 (1)(c) (213/91) Action Supervisor	Observed scaffolding that had an elevation greater than 2.4 meters without a guardrail in place. Discussed the issue with the supervisor and he shall ensure that guardrails are installed on elevations to prevent workers from a fall of greater than 2.4m. Guardrails should have a top rail, mid rail, and toe board to meet compliance.

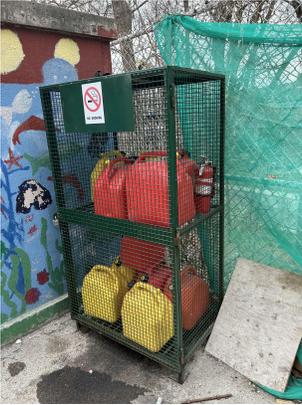
12.

Item Flammable Liquid Storage Regulation #43 (2) (213/91) Action N/A	Observed that flammable liquids are being stored in well ventilated areas, which meets compliance.
