Site Safety Inspection Report

Company Toronto District School Board	Location/Address 357 Runnymede Road, High Park North, Old Toronto, Toronto, Ontario, M6P 3C5, Canada		
Date May 20, 2025	Time In: 8:30 AM	Time Out: 10:30 AM	Weather Few Clouds, 12°C, 9 km/h Winds
Project	Supervisor TCM - Cillian	Safety Inspector Mike Harrison	Title TDSB Site Inspection Report for Runnymede JSPS at 357 Runnymede Rd Project May 20, 2025

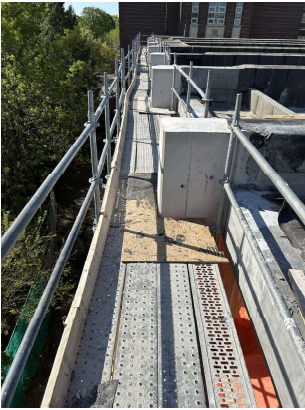
2.

Item Full Scaffold Platforms Regulation #135 (1)(b) (213/91) Action N/A	Observed that a scaffold platform that is 2.4 meters or more above a floor, roof, or surface consists of planks laid tightly side by side for the full width of the scaffold, which meets compliance.

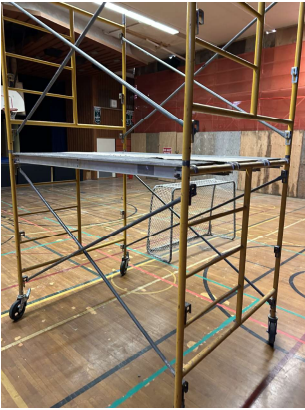
Item #	Act / Reg / Follow-Up	Observations
11.

Item Scaffolding - Bracing Regulation #128 (1)(a) (213/91) Action N/A	Observed that the uprights of the scaffolding have been braced diagonally in the horizontal and vertical planes to prevent lateral movement, which meets compliance.
