# Site Safety Inspection Report

Company Toronto District School Board	Location/Address 357 Runnymede Road, High Park North, Old Toronto, Toronto, Ontario, M6P 3C5, Canada		
Date May 27, 2025	Time In: 8:30 AM	Time Out: 10:30 AM	Weather Few Clouds, 14°C, 3 km/h Winds
Project	Supervisor TCM - Cillian	Safety Inspector Mike Harrison	Title TDSB Site Inspection Report for Runnymede JSPS at 357 Runnymede Rd Project May 27, 2025

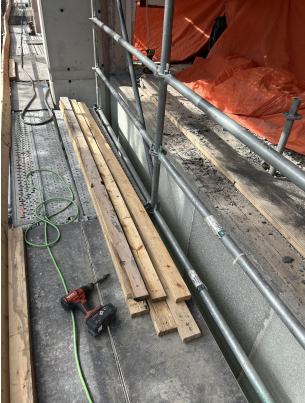
4.

<b>Item</b> Material Storage <b>Regulation</b> #39 (213/91) <b>Action</b> N/A	Observed wood and other materials on site stored in a manner to prevent tipping, collapsing or rolling as to not endanger a worker, which meets compliance.

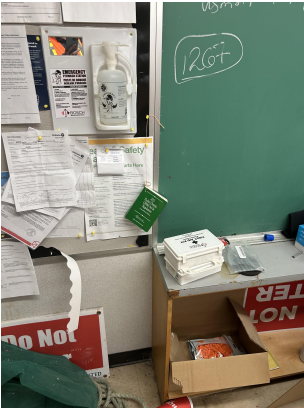
Item #	Act / Reg / Follow-Up	Observations
5.

<b>Item</b> First Aid Station <b>Regulation</b> #1 (1) (1101) <b>Action</b> N/A	Observed that a first aid station had an adequately supplied first aid kit for their workforce, Form 82 posted, and the certificates of trained first aiders on duty, which meets compliance.

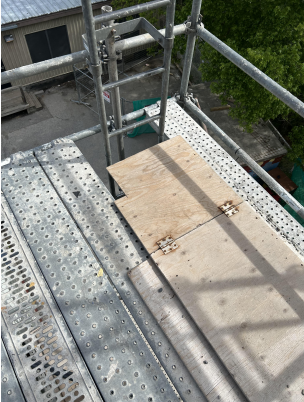
6.

<b>Item</b> Scaffolding - Unguarded Openings <b>Regulation</b> #135 (1)(e) (213/91) <b>Action</b> N/A	Observed that openings in the scaffolding are guarded by a hatch and closed to ensure the safety of the worker, which meets compliance.

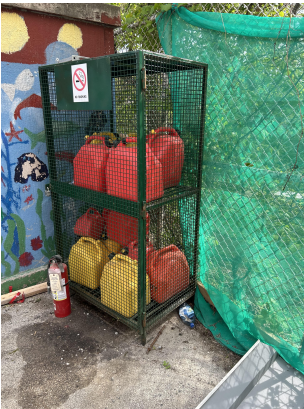
7.

<b>Item</b> Flammable Liquid Storage <b>Regulation</b> #43 (2) (213/91) <b>Action</b> N/A	Observed that flammable liquids are being stored in well ventilated areas, which meets compliance.
