Site Safety Inspection Report

Company Toronto District School Board	Location/Address 357 Runnymede Road, High Park North, Old Toronto, Toronto, Ontario, M6P 3C5, Canada		
Date May 5, 2025	Time In: 8:30 AM	Time Out: 10:30 AM	Weather Overcast Clouds, 12°C, 6 km/h Winds
Project	Supervisor TCM - Cillian	Safety Inspector Mike Harrison	Title TDSB Site Inspection Report for Runnymede JSPS at 357 Runnymede Rd Project May 5, 2025

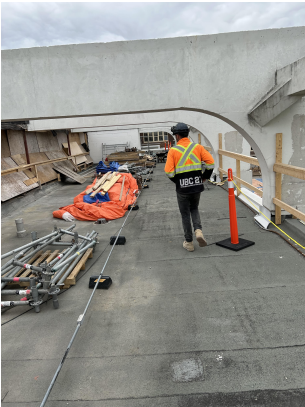
2.

Item PPE Regulation #21 (213/91) Action N/A	Observed workers on site are wearing the required PPE for the safe performance of their tasks, which meets compliance.

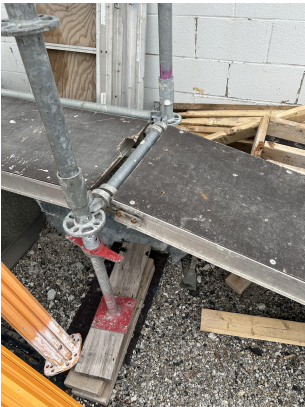
3.

Item Scaffolding - Footings, Sills, Supports Regulation #128 (1)(c) (213/91) Action Supervisor	Per previous report, observed that the footings, sills and supports of the scaffolding are not level and secure. Discussed the issue with the supervisor and he shall ensure that footings/sills/supports are on level ground and secured to meet compliance.

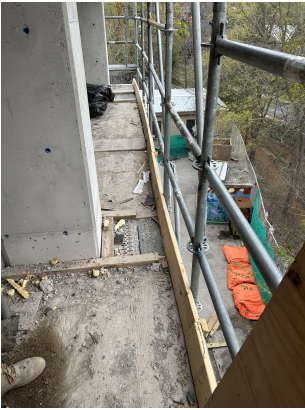
Item #	Act / Reg / Follow-Up	Observations
4.

<p>Item Access / Egress - Emergencies</p> <p>Regulation #71 (213/91)</p> <p>Action Issue Corrected</p>	Per previous report, observed access/egress travel routes are now clear of obstructions for workers to exit in the event of an emergency, which meets compliance.

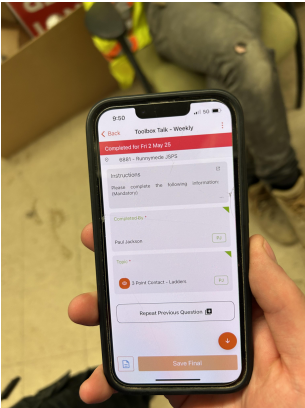
6.

<p>Item Duties of a Supervisor - Inspections / Hazard Communication</p> <p>Regulation #27 (2)(a) OHSA</p> <p>Action N/A</p>	Observed supervisor sign off on site inspections, completion of hazard communication at the project through tool box talks and/or safety meetings, which meets the requirements of OHSA.

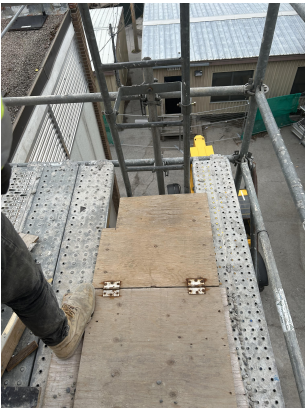
7.

<p>Item Scaffolding - Unguarded Openings</p> <p>Regulation #135 (1)(e) (213/91)</p> <p>Action N/A</p>	Observed that openings in the scaffolding are guarded by a hatch and closed to ensure the safety of the worker, which meets compliance.
