# Site Safety Inspection Report

Company Toronto District School Board	Location/Address 357 Runnymede Road, High Park North, Old Toronto, Toronto, Ontario, M6P 3C5, Canada		
Date April 7, 2025	Time In: 8:30 AM	Time Out: 10:30 AM	Weather Clear Sky, 3°C, 5 km/h Winds
Project	Supervisor TCM - Cillian	Safety Inspector Mike Harrison	Title TDSB Site Inspection Report for Runnymede JSPS at 357 Runnymede Rd Project Apr 7, 2025

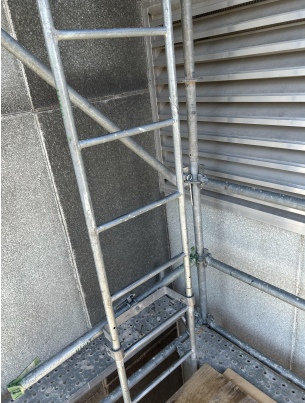
4.

<b>Item</b> Scaffolding - Access Means <b>Regulation</b> #135 (1)(d) (213/91) <b>Action</b> N/A	Observed an adequate means of access/egress to the scaffolding is available, which meets compliance.

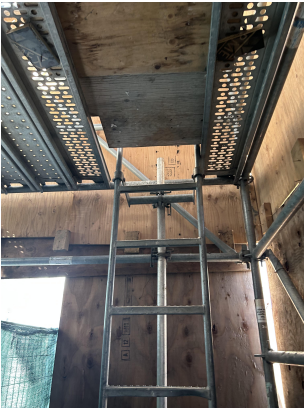
Item #	Act / Reg / Follow-Up	Observations
5.

<b>Item</b> Scaffolding - Unguarded Openings <b>Regulation</b> #135 (1)(e) (213/91) <b>Action</b> N/A	Observed that openings in the scaffolding are guarded by a hatch and closed to ensure the safety of the worker, which meets compliance.

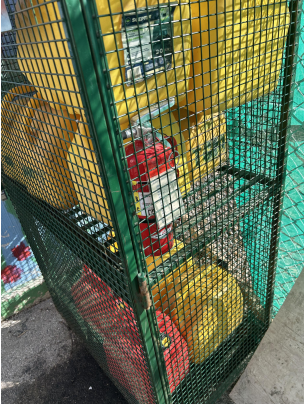
6.

<b>Item</b> Fire Extinguisher - Inspection <b>Regulation</b> #55 (213/91) <b>Action</b> N/A	Observed fire extinguisher with inspection tags in place and inspections dated and signed off monthly, which meets compliance.

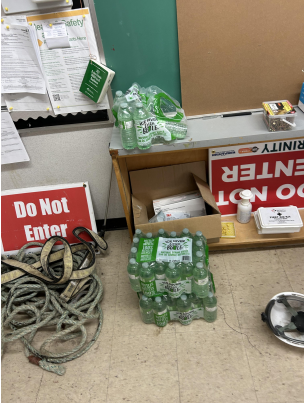
7.

<b>Item</b> Drinking Water <b>Regulation</b> #28 (1) (213/91) <b>Action</b> N/A	Observed that drinking water is readily available to the workers at the project, which meets compliance.

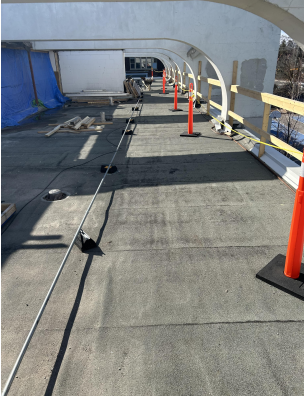
8.

<b>Item</b> Access / Egress - Maintenance <b>Regulation</b> #72 (213/91) <b>Action</b> On-Going	Observed access/egress routes through the work areas are clear of material/debris and other obstructions, which meets compliance.
