Site Safety Inspection Report

Company Toronto District School Board	Location/Address 357 Runnymede Road, High Park North, Old Toronto, Toronto, Ontario, M6P 3C5, Canada		
Date March 11, 2025	Time In: 9:30 AM	Time Out: 11:30 AM	Weather Few Clouds, 6°C, 7 km/h Winds
Project	Supervisor TCM - Cillian	Safety Inspector Mike Harrison	Title TDSB Site Inspection Report for Runnymede JSPS at 357 Runnymede Rd Project Mar 11, 2025

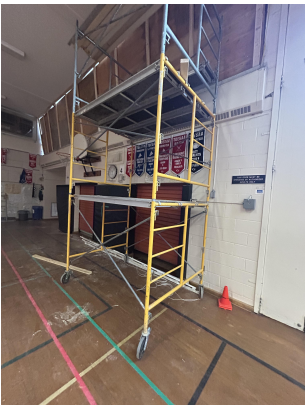
4.

Item Scaffolding on Castors/Wheels - Outriggers Regulation #129 (2) (213/91) Action Supervisor	Observed scaffolding mounted on castors/wheels at a height exceeding three times the least lateral dimension of the scaffolding. Discussed the issue with the supervisor and he shall ensure outriggers are installed so that the height of the scaffolding does not exceed three times the least lateral dimension of the scaffold system to meet compliance.

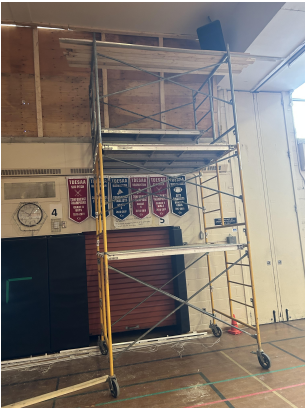
Item #	Act / Reg / Follow-Up	Observations
5.

<p>Item Scaffolding - Access Means Regulation #135 (1)(d) (213/91) Action Supervisor</p>	Observed scaffolding being used on site that does not have a means of access/egress. Discussed the issue with the supervisor and he shall ensure that an adequate means of access/egress is available (stairs, ramp, runway, ladder) for the workers to access/egress the scaffolding to meet compliance.

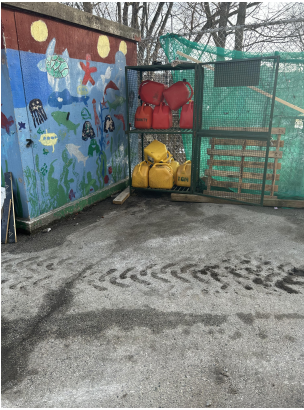
Item #	Act / Reg / Follow-Up	Observations
10.

Item Fire Extinguisher - Flammables/Combustibles Regulation #52 (2)(a) (213/91) Action Supervisor	Per previous report, observed fire extinguishing equipment is not available where flammable liquids/combustibles are being stored. Discussed the issue with the supervisor and he shall ensure fire extinguishing equipment is available where flammable liquids/combustibles are being stored/handled/used to meet compliance.

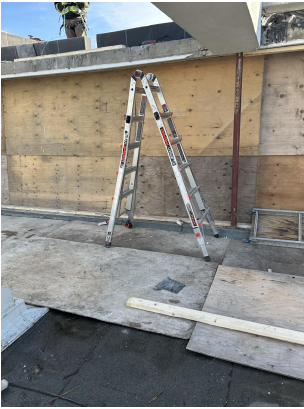
13.

Item Step Ladder Set Up Regulation #83 (1) (213/91) Action N/A	Observed a step ladder being used on site with the legs fully extended and locked in place to prevent movement, which meets compliance.
