Site Safety Inspection Report

| Company Toronto District School Board | Location/Address 357 Runnymede Road, High Park North, Old Toronto, Toronto, Ontario, M6P 3C5, Canada | | |
| Project | Supervisor TCM - Cillian | Safety Inspector Mike Harrison | Title TDSB Site Inspection Report for Runnymede JSPS at 357 Runnymede Rd Project Mar 24, 2025 |

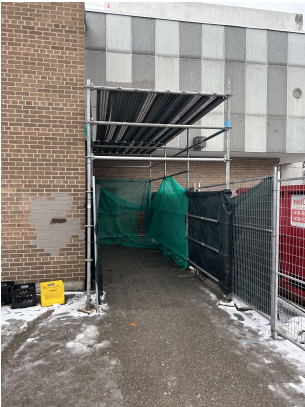
| Item # | Act / Reg / Follow-Up | Observations |
|--|--|--|
| 2. | Item Overhead Protection Regulation #34 (1)(a)(b) (213/91) Action N/A | Observed overhead protection provided at access and egress points of the project and above work areas where work was being performed overhead, which meets compliance. |

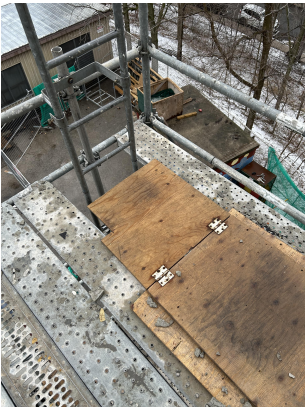
| Item # | Act / Reg / Follow-Up | Observations |
|--|--|--|
| 3. | Item Scaffolding - Unguarded Openings Regulation #135 (1)(e) (213/91) Action N/A | Observed that openings in the scaffolding are guarded by a hatch and closed to ensure the safety of the worker, which meets compliance. |

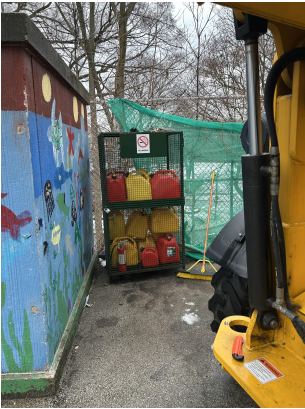
| Item # | Act / Reg / Follow-Up | Observations |
|--|--|---|
| 4. | Item Flammable Liquid Storage Regulation #43 (2) (213/91) Action N/A | Observed that flammable liquids are being stored in well ventilated areas, which meets compliance. |

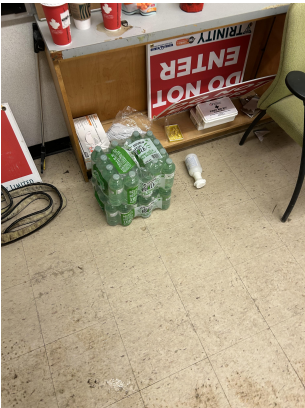
| Item # | Act / Reg / Follow-Up | Observations |
|--|--|---|
| 5. | Item Drinking Water Regulation #28 (1) (213/91) Action N/A | Observed that drinking water is readily available to the workers at the project, which meets compliance. |

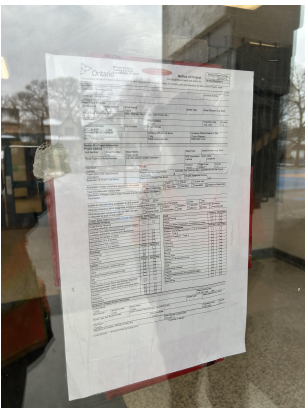
| Item # | Act / Reg / Follow-Up | Observations |
|--|--|---|
| 7. | Item Notice of Project - Ont. Reg. 213/91 Construction Projects - Section 13 Regulation Notice of Project - Ont. Reg. 213/91 Construction Projects - Section 13 Action Issue Corrected | Per previous report, observed that an updated Notice of Project is now posted in a conspicuous place on the site, which meets compliance. |

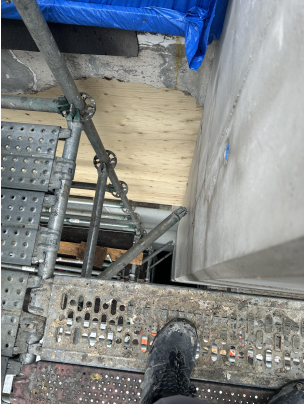
| Item # | Act / Reg / Follow-Up | Observations |
|---|---|--|
| 10. | <p>Item Guardrail or Protective Covering - Openings</p> <p>Regulation #26.3 (2) (213/91)</p> <p>Action Supervisor</p> | Observed an opening in the work surface that endangers the worker. Discussed the issue with the supervisor and he shall ensure that a guardrail is in place or the opening is securely covered, adequately identified as covering an opening, is made of material that is capable of supporting all loads it may be subjected to and is capable of supporting a live load of at least 2.4 kilonewtons per square metre without exceeding the allowable unit stresses for the material used to meet compliance. |
