Site Safety Inspection Report

Company Toronto District School Board	Location/Address 357 Runnymede Road, High Park North, Old Toronto, Toronto, Ontario, M6P 3C5, Canada		
Date May 12, 2025	Time In: 8:30 AM	Time Out: 10:30 AM	Weather Clear Sky, 12°C, 1 km/h Winds
Project	Supervisor TCM - Cillian	Safety Inspector Mike Harrison	Title TDSB Site Inspection Report for Runnymede JSPS at 357 Runnymede Rd Project May 12, 2025

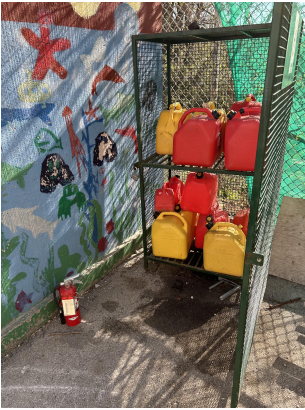
Item #	Act / Reg / Follow-Up	Observations
5.

<p>Item Fire Extinguisher - Flammables/Combustibles Regulation #52 (2)(a) (213/91) Action N/A</p>	Observed fire extinguishing equipment available where flammable liquids/combustibles are being stored, handled and used (i.e. compressed gas cages, propane lift trucks and mobile equipment), which meets compliance.

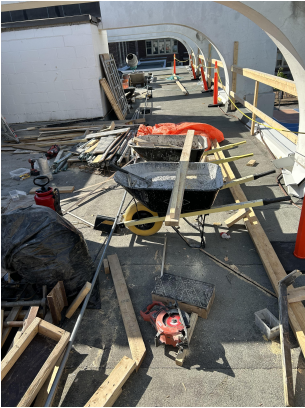
8.

<p>Item Access / Egress - Emergencies Regulation #71 (213/91) Action Supervisor</p>	Observed access/egress travel routes are obstructed with materials and debris. Discussed the issue with the supervisor and he shall ensure access/egress travel routes are clear of obstructions for workers to exit in the event of an emergency to meet compliance.
