## **ASBESTOS & LEAD ABATEMENT COMPLETION REPORT**

## JOHN FISHER PUBLIC SCHOOL 40 ERSKINE AVENUE TORONTO, ONTARIO

October 25, 2017 (revised)

ECOH Project Number: 17201-PR4

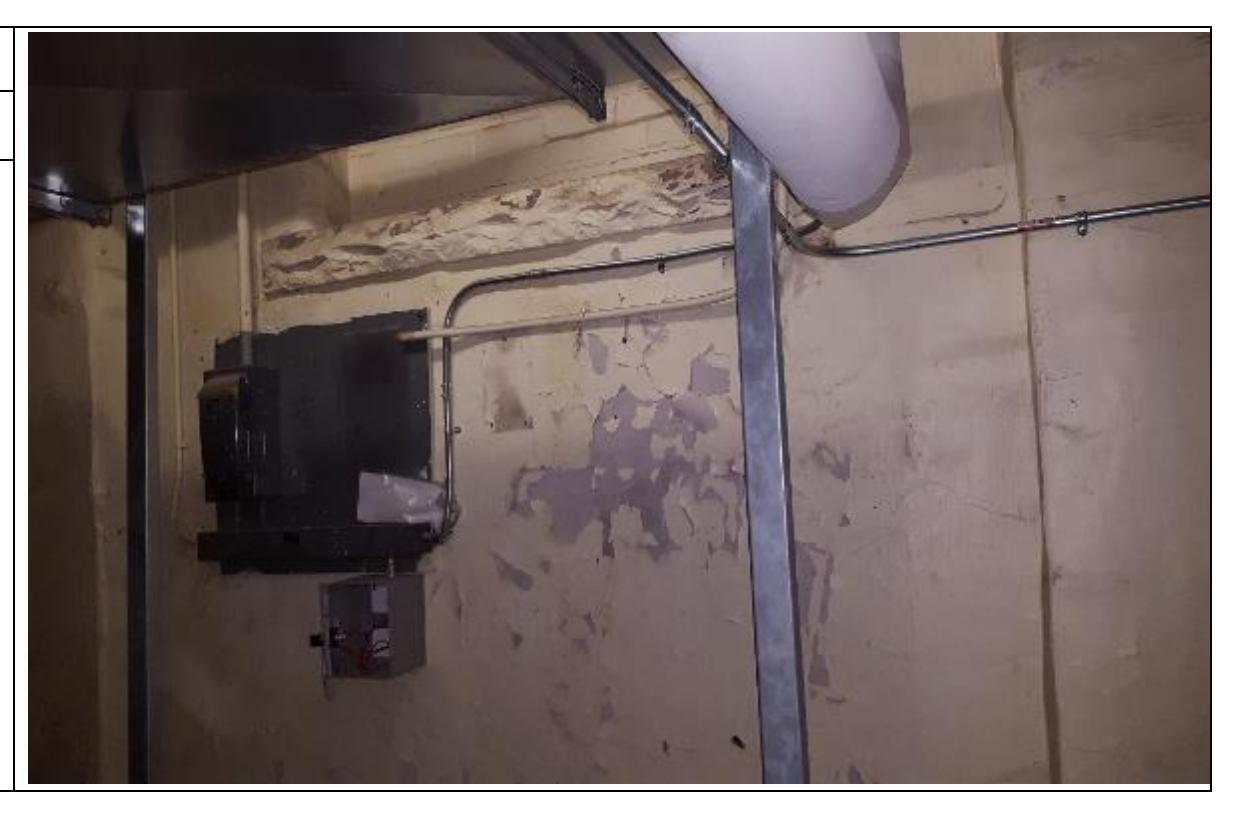
Flecking paint on walls is present throughout the Project Area.

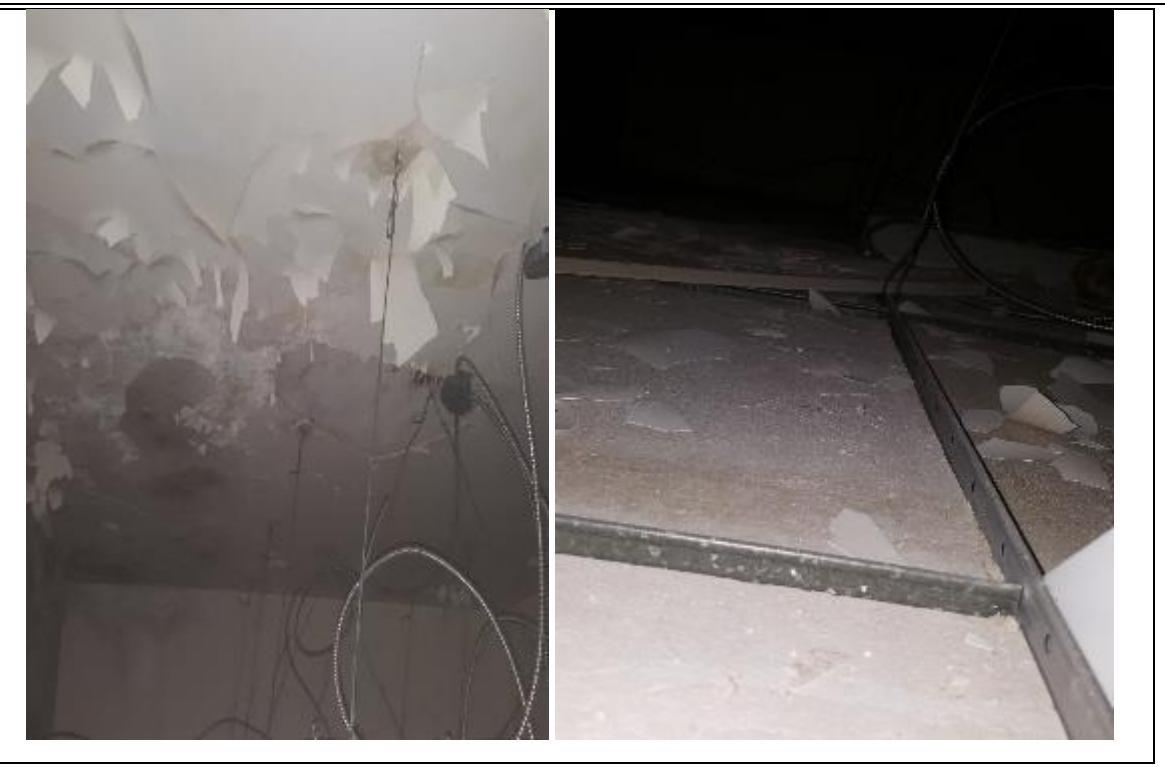
#### Photo No. 2.

Representative photo of flaking paint above ceiling.

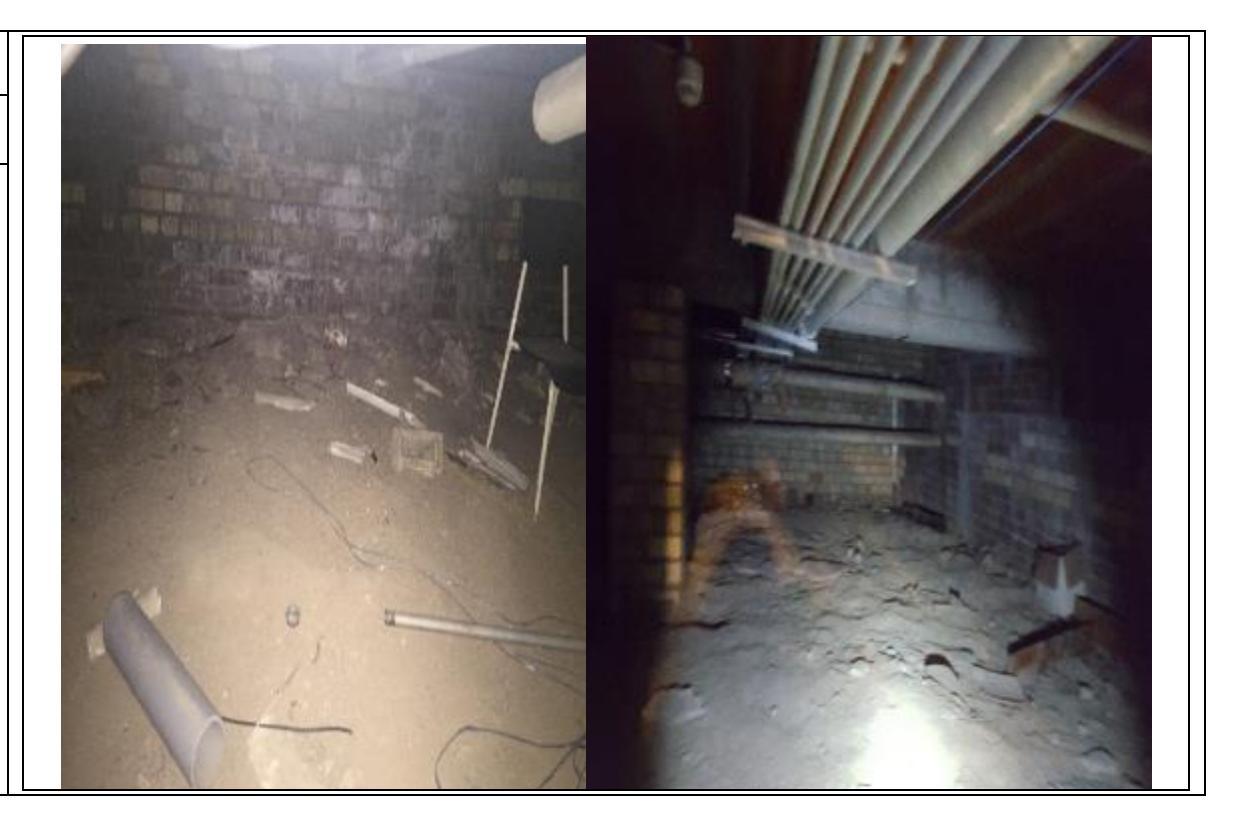
Basement: Crawlspace (Location 73548)

Insulation on straightrun pipe and pipe insulation debris is present throughout the Work Area 6.

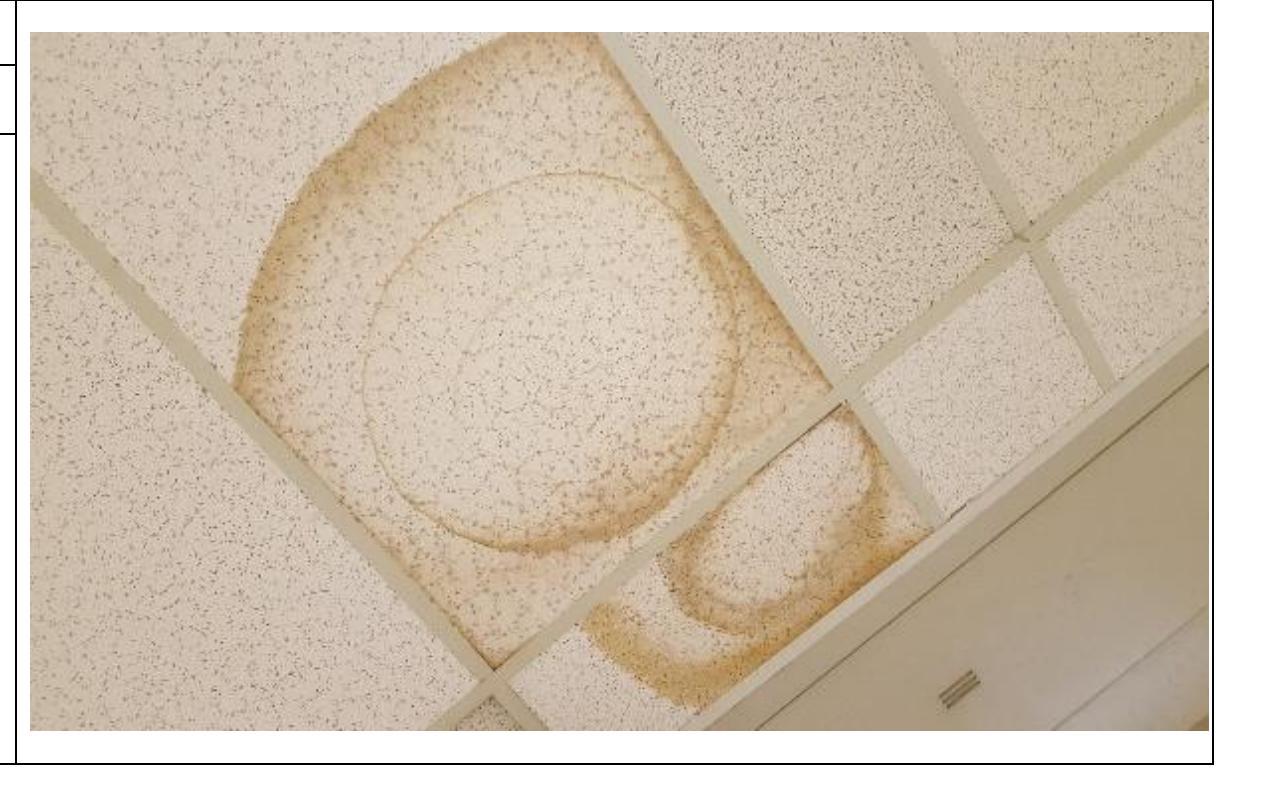
## Photo No. 6.

Mould damage on ceiling tile present throughout the Project Area.

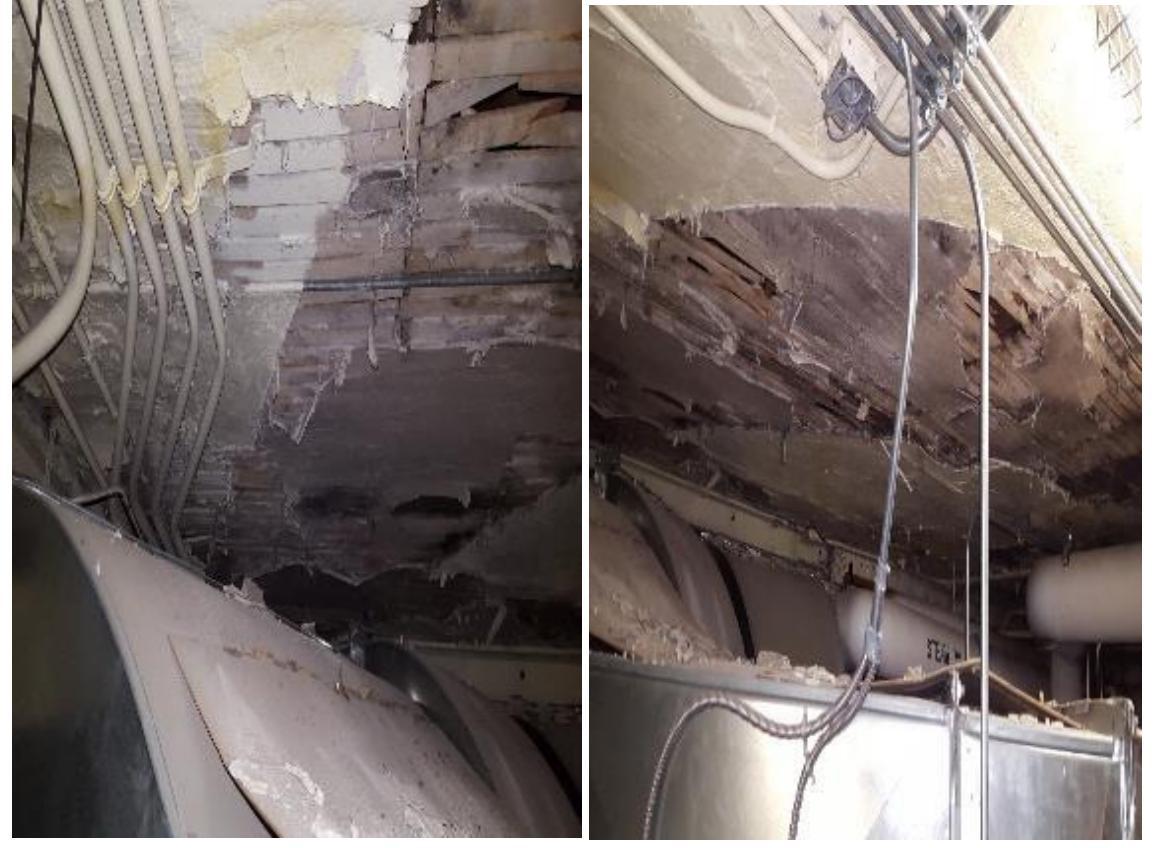
Date: June 14, 2017Description:Representative PhotoPoor condition plaster<br/>present throughout the<br/>Project Area.

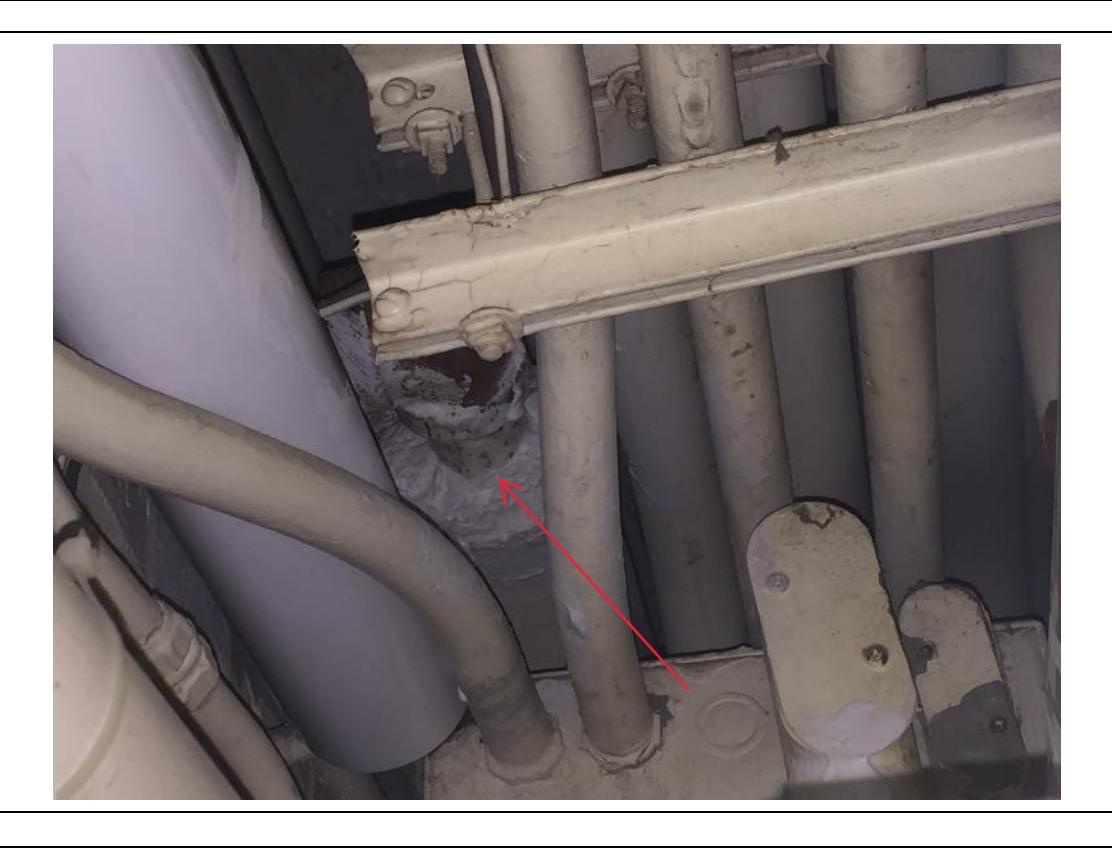
Aircell insulation present above Electrical Room door in the Basement Corridor. Material has been encapsulated as it was not able to be removed.

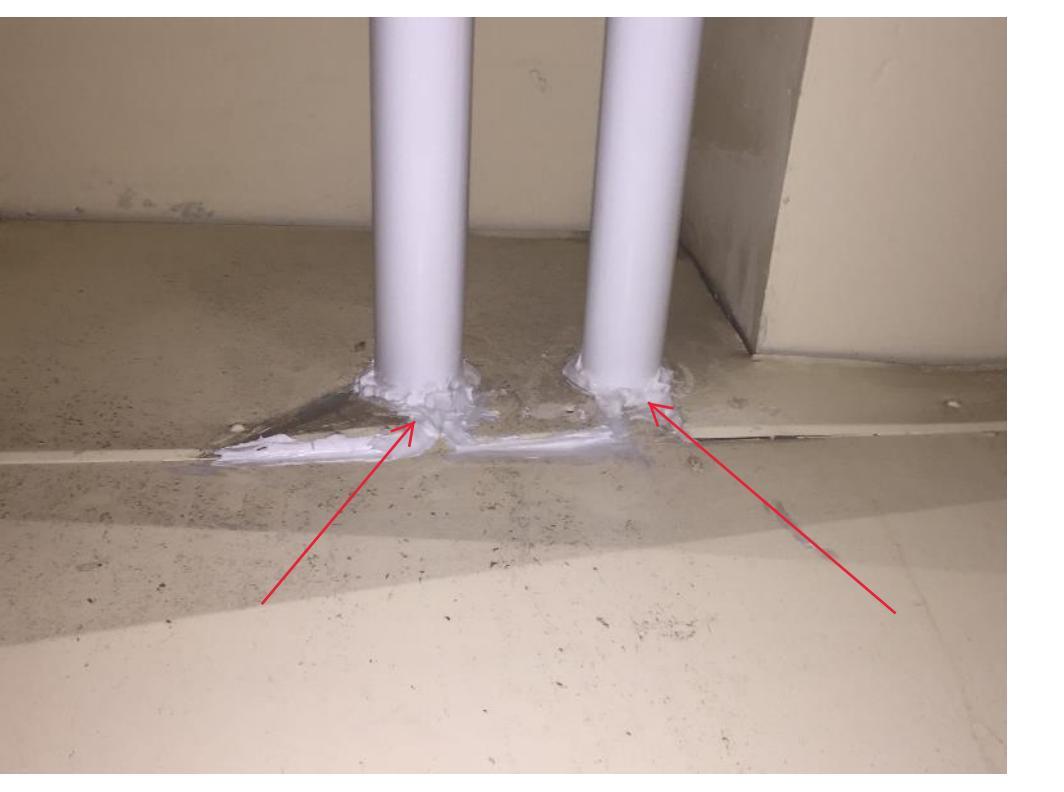
#### Photo No. 2.

Pipe insulation suspected to be present inside duct casing. Open sections in the Basement Corridor were caulked (to best extent possible).

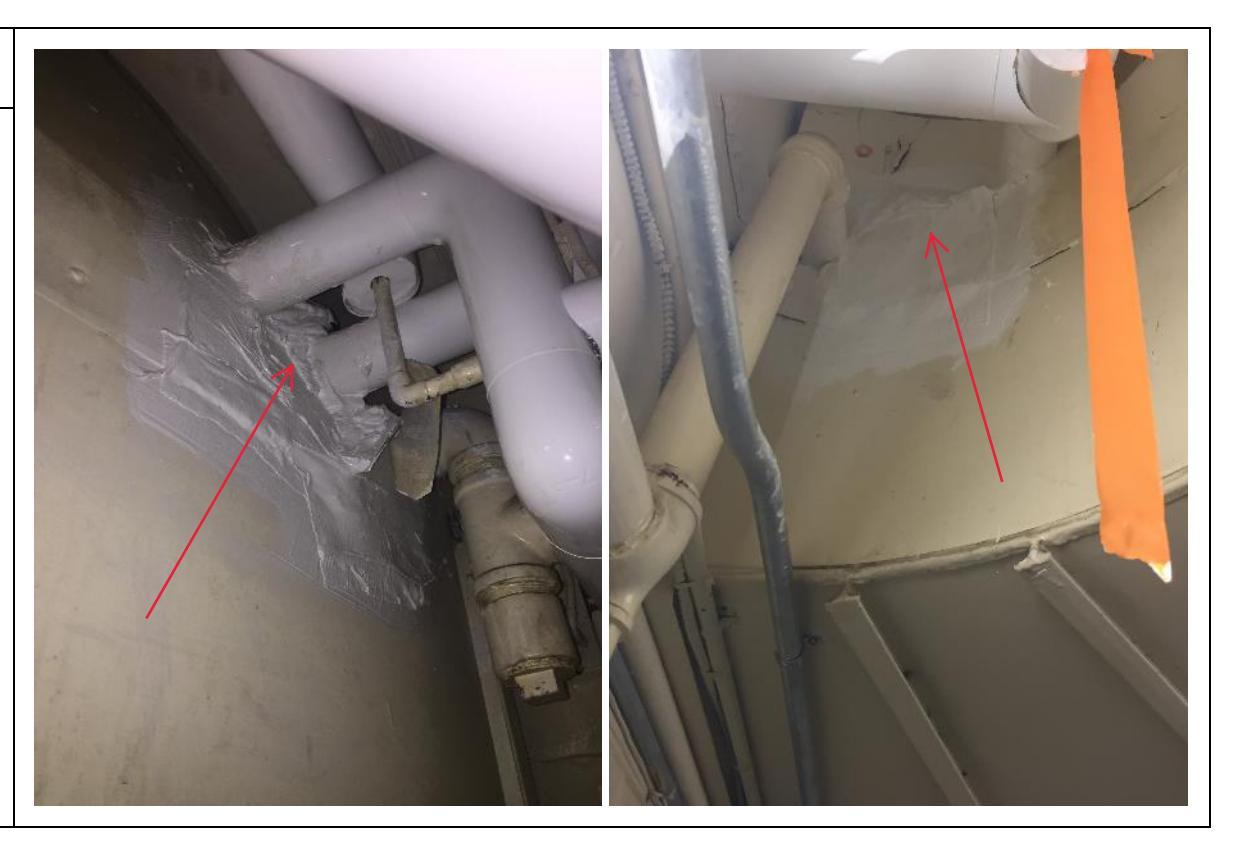
Pipe insulation suspected to be present inside duct casing. Open sections in the Basement Corridor were caulked and covered (to best extent possible).

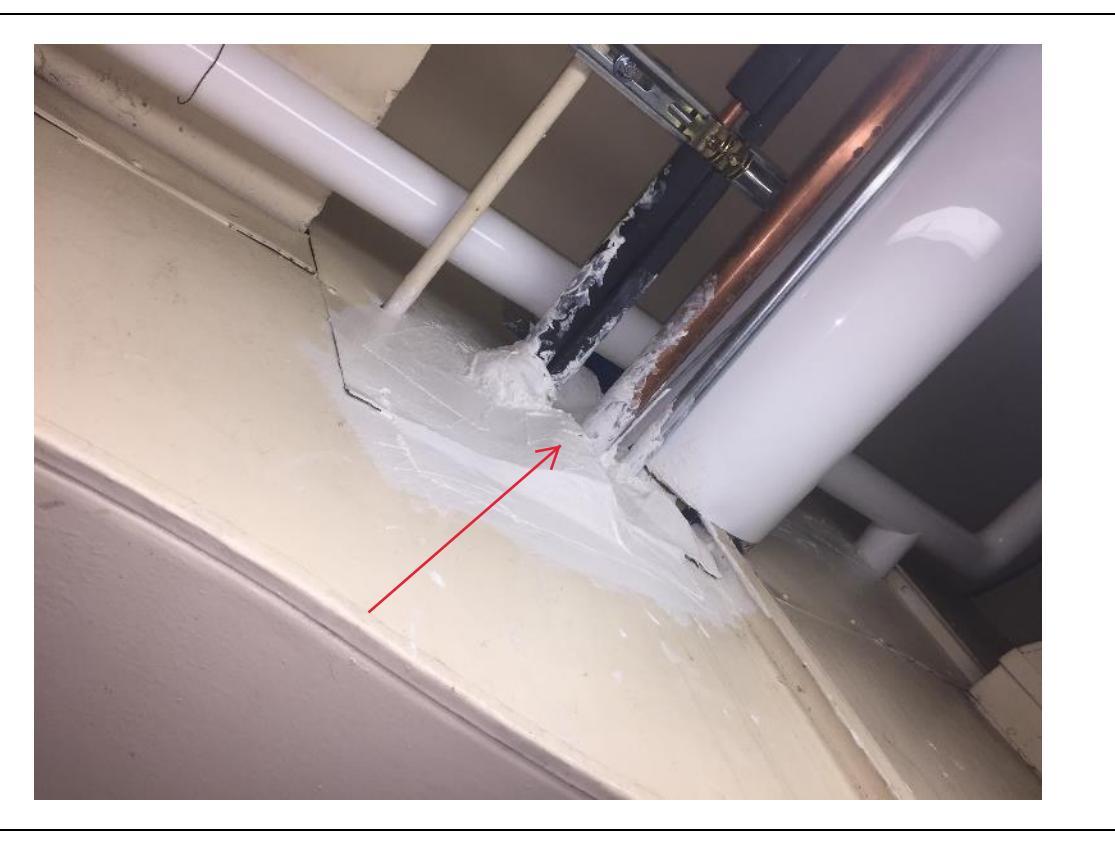
### Photo No. 4.

Pipe insulation suspected to be present inside duct casing. Open sections in the Basement Corridor were caulked and covered (to best extent possible).
