## **ASBESTOS & LEAD ABATEMENT COMPLETION REPORT**

## JOHN FISHER PUBLIC SCHOOL 40 ERSKINE AVENUE TORONTO, ONTARIO

October 25, 2017 (revised)

ECOH Project Number: 17201-PR4

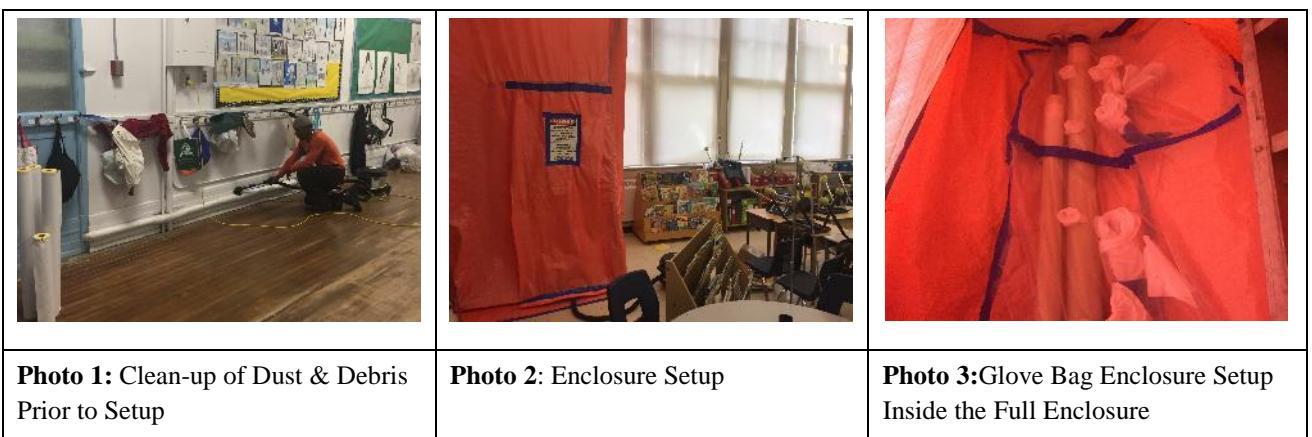
- 5. Prior to commencing removal, ECOH performed a pre-contamination visual inspection of each Type 2 enclosure and Glove-Bag enclosure. Minor deficiencies observed by the ECOH inspector in the enclosures and/or perimeter seals were brought to the attention of the HighPoint Site Foreman and repaired immediately.

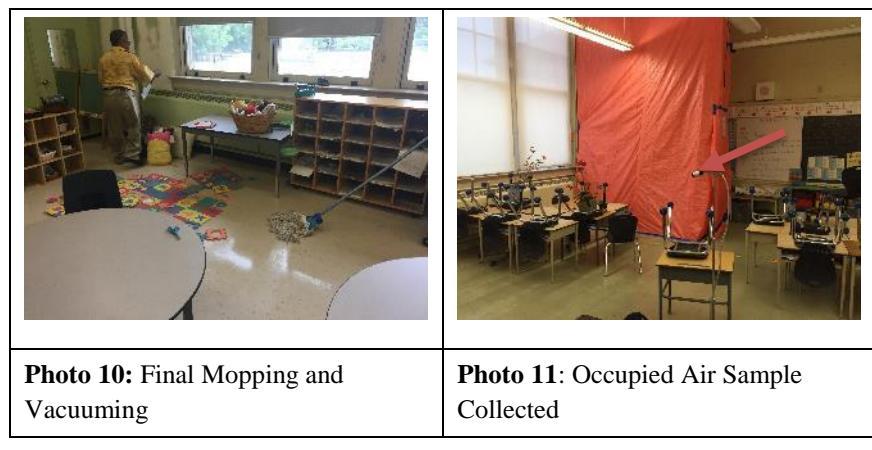
- 12. Following the removal of the Type 2 enclosures, all parties (ECOH, Highpoint foreman, School Caretaker and the TDSB Health & Safety Inspector) performed a final walkthrough to ensure all pipes where removal occurred had been reinsulated with new fibreglass insulation and that all areas were left as found (Photo 9 & 10).
- 13. ECOH collected five (5) occupied air samples (sample 17201-PR4-PCM-01 to 05) to assess airborne fiber concentrations during the removal work. The results for the air monitoring analysis are reported in Table 1 (Photo 11).

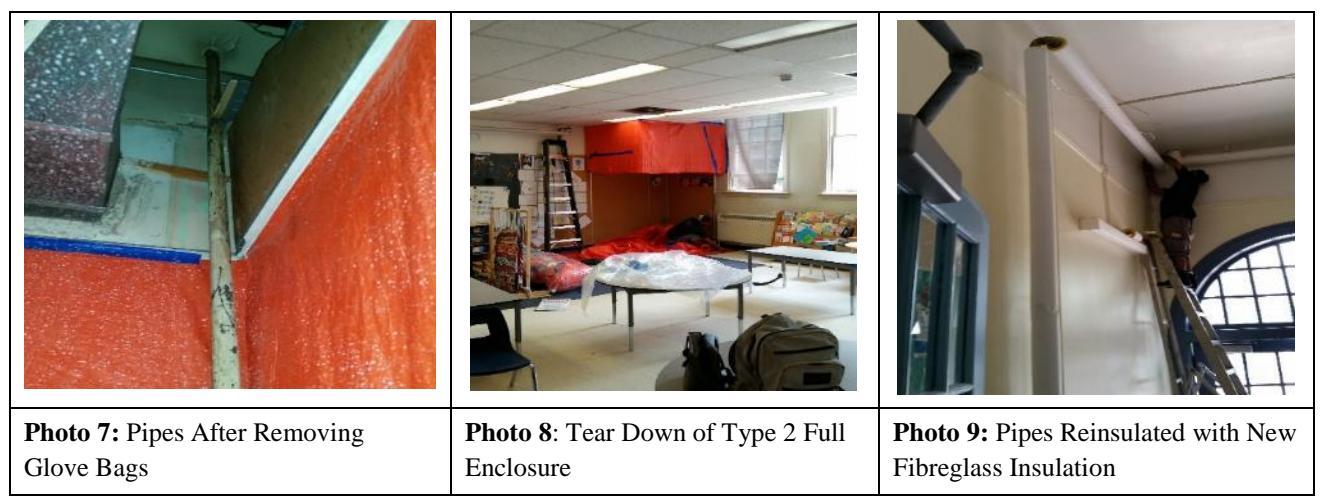
- 12. Following the removal of the Type 2 enclosures, all parties (ECOH, Highpoint foreman, School Caretaker and the TDSB Health & Safety Inspector) performed a final walkthrough to ensure all pipes where removal occurred had been reinsulated with new fibreglass insulation and that all areas were left as found (Photo 9 & 10).
- 13. ECOH collected eight (8) occupied air samples (sample 17201-PR4-PCM-06 to 12) to assess airborne fiber concentrations during the removal work. The results for the air monitoring analysis are reported in Table 1 (Photo 11).

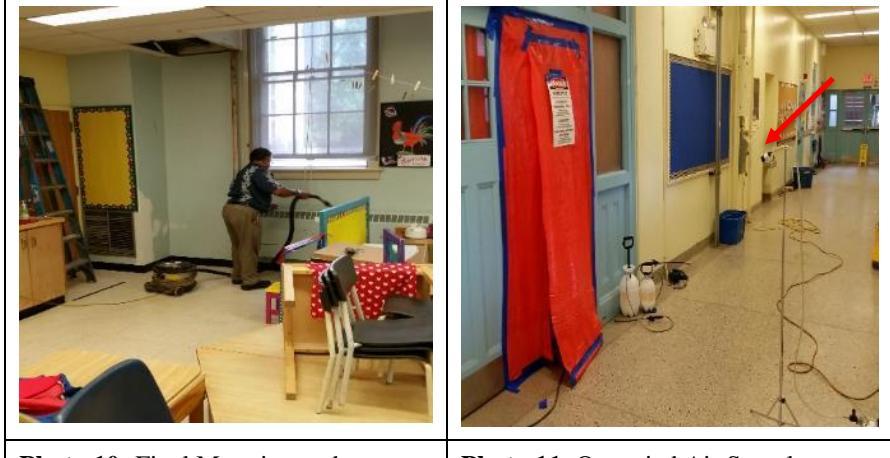
**Photo 10:** Final Mopping and Vacuuming

Photo 11: Occupied Air Sample Collected
